APPENDIX D

Photolog

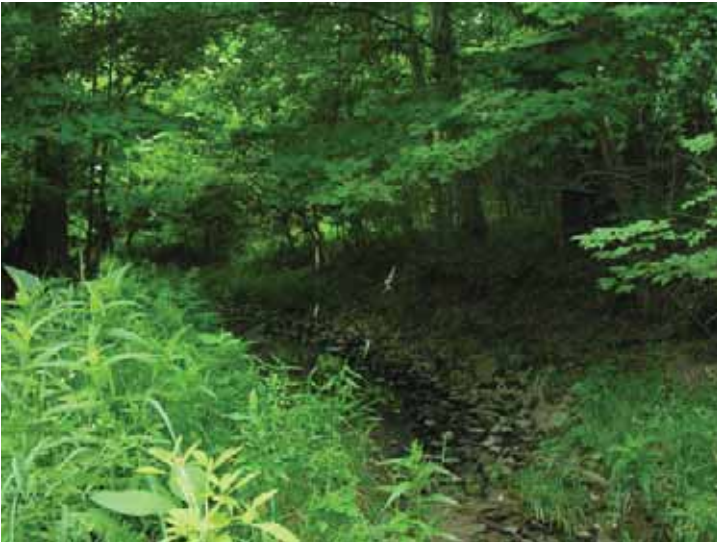
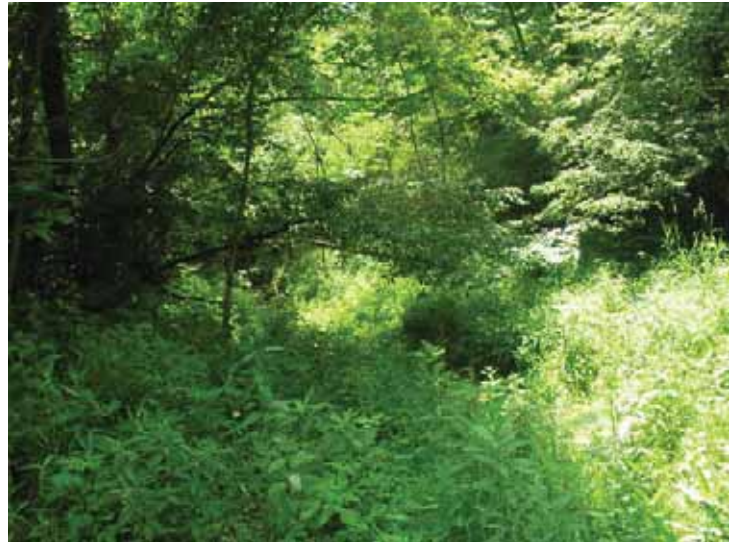
Photographs 1-2. The tributary to Cove 4, (Kiddie Corral) is heavily vegetated with a forest canopy and herbaceous understory vegetation.

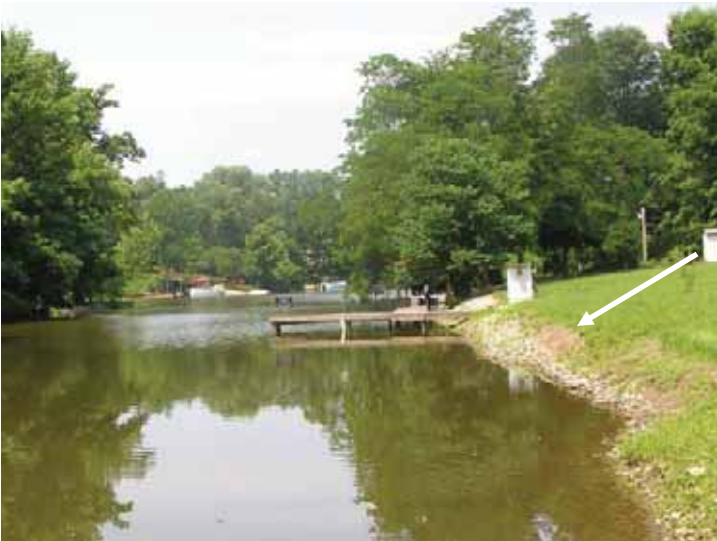
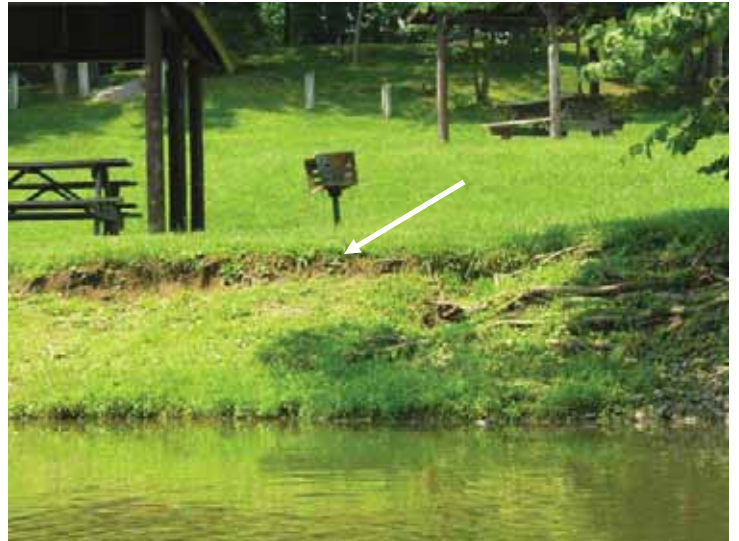
Photographs 3-4. The shoreline is eroding (indicated by white arrows in photos) at the upstream end of Cove 4 (Kiddie Corral).

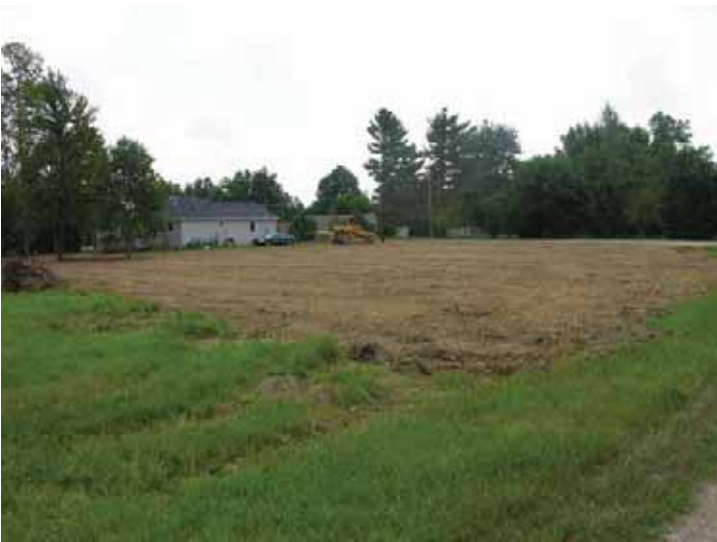
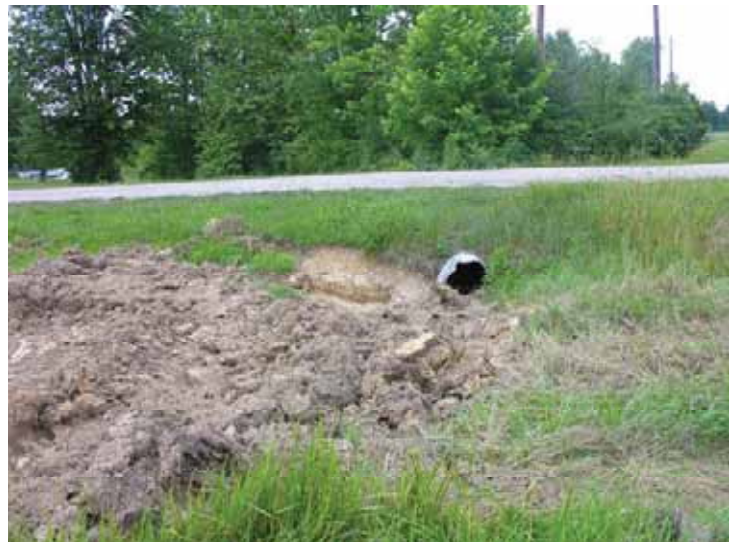
Photographs 5-6. The lot located at wagon Wheel Dr. and Indian Dr. had no silt fence installed. This culvert (right) drains runoff from the lot to Cove 4.

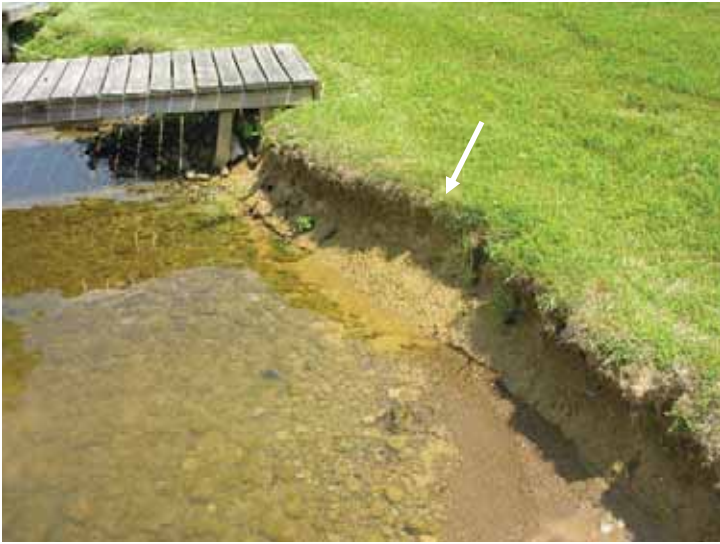
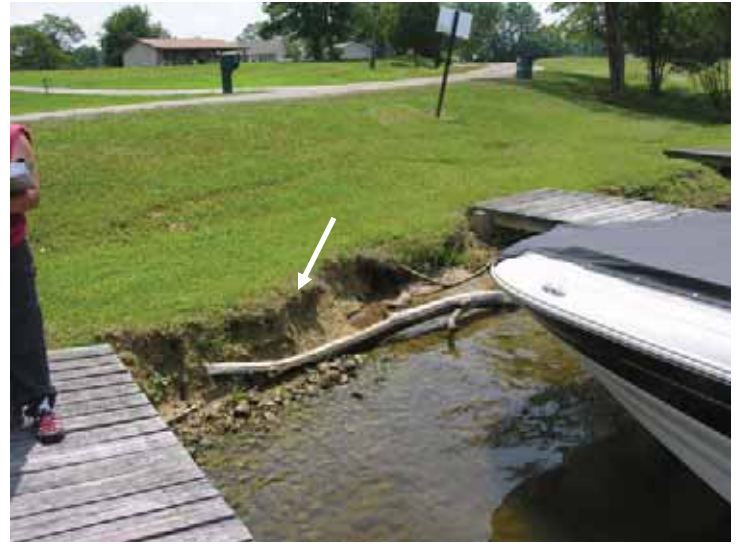
Photographs 7-8. Erosion along Sioux cove (indicated by white arrows), likely caused by waves emanating in main body of the lake.

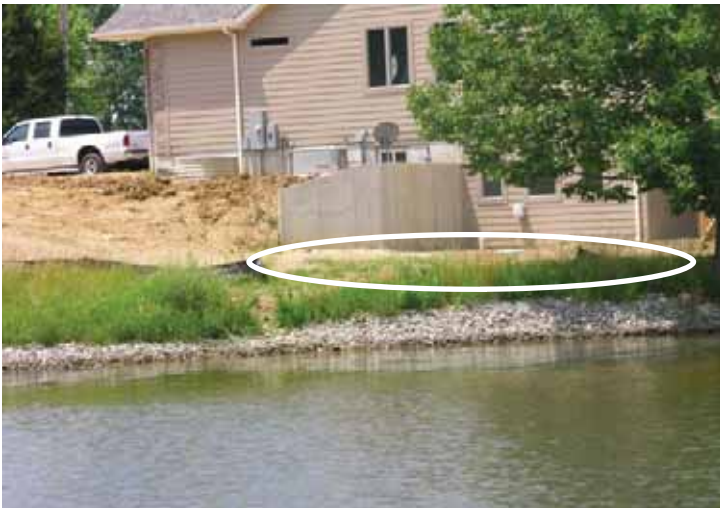
Photograph 9. Lot 759, in Sioux Cove's watershed, had a gap in its silt fence (circled in the photo).

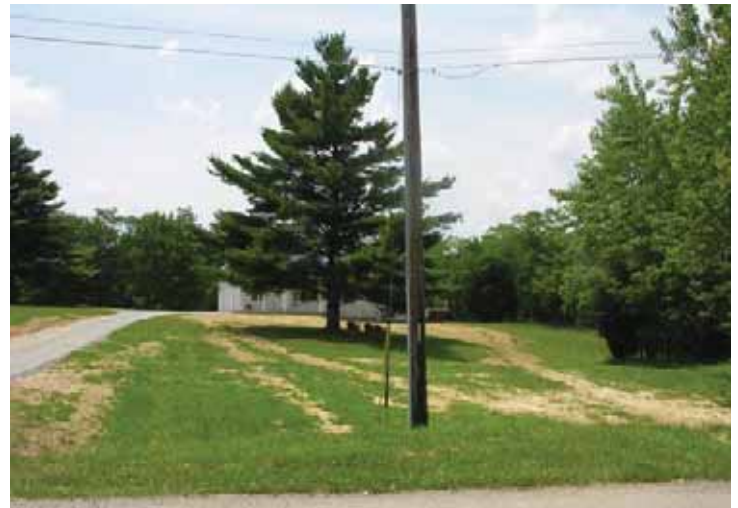
Photograph 10. A newly seeded lawn (brown areas are bare ground) along Cove 6 that did not have any sediment or erosion controls.

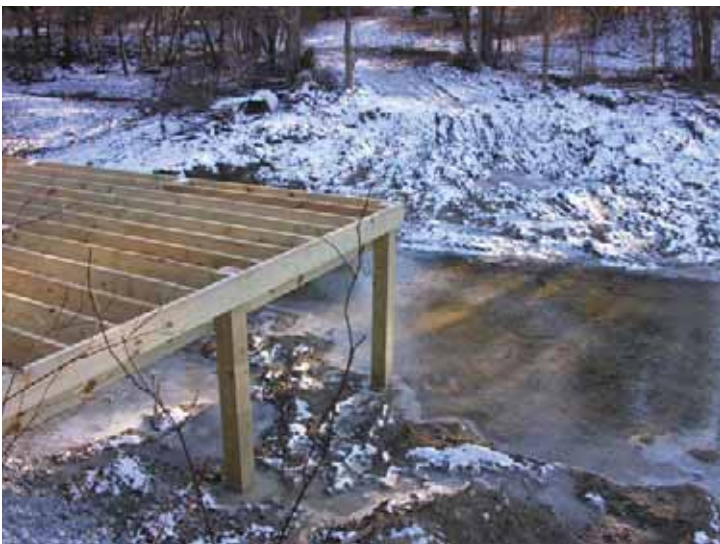
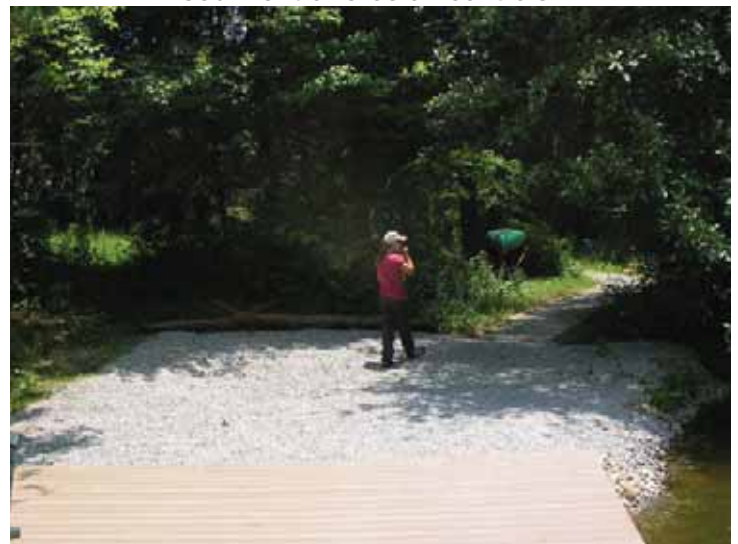
Photographs 11-12. This dock, located at the head of Cove 6, was installed over winter 2011. No erosion or sediment controls were used during installation.

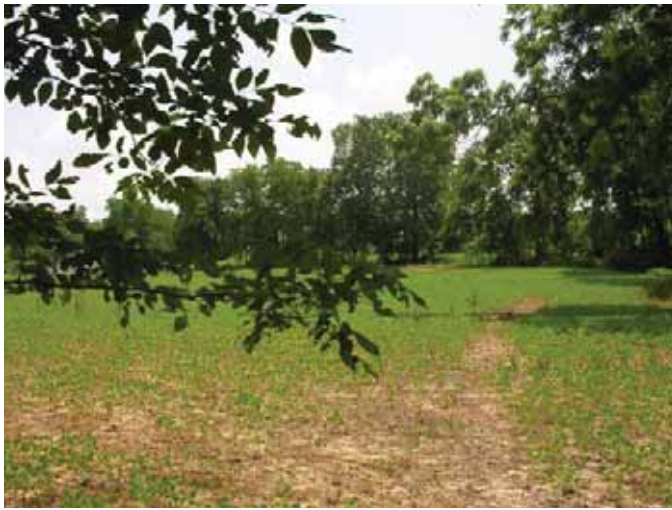
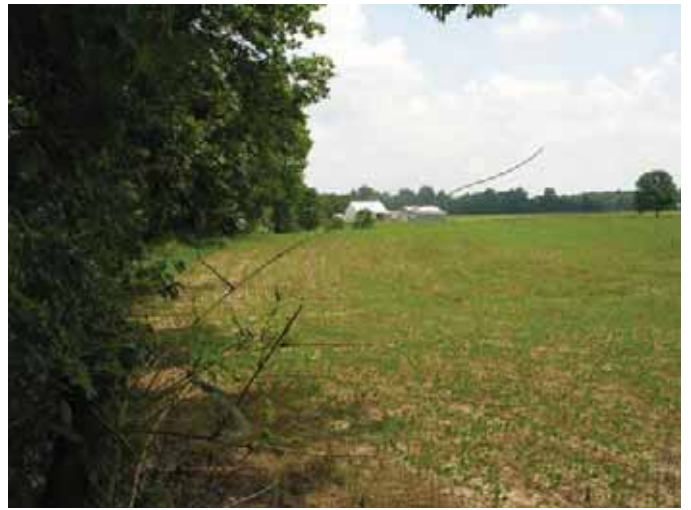
Photographs 13-14. Soy bean fields adjacent to the wooded riparian corridor of Straight Creek, west of Waynoka Dr.

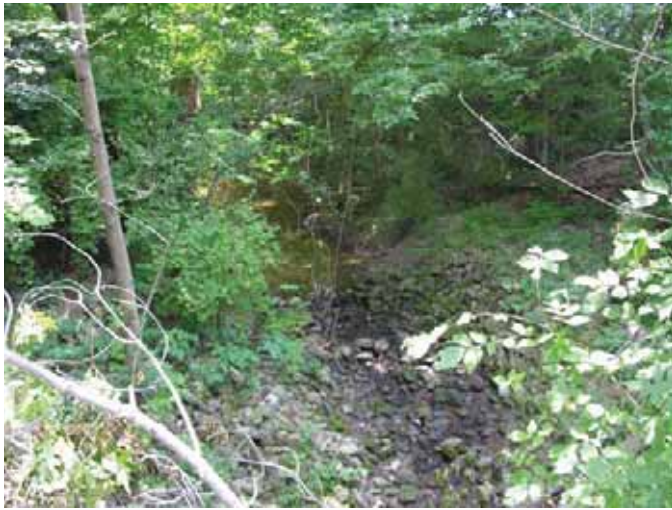
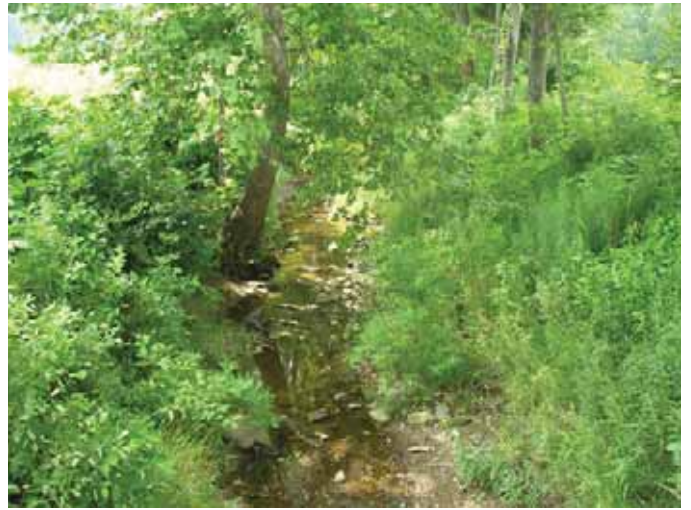
Photographs 15-16. Straight Creek west of Waynoka Dr. (left) and west of Martin Alexander Rd. (right).

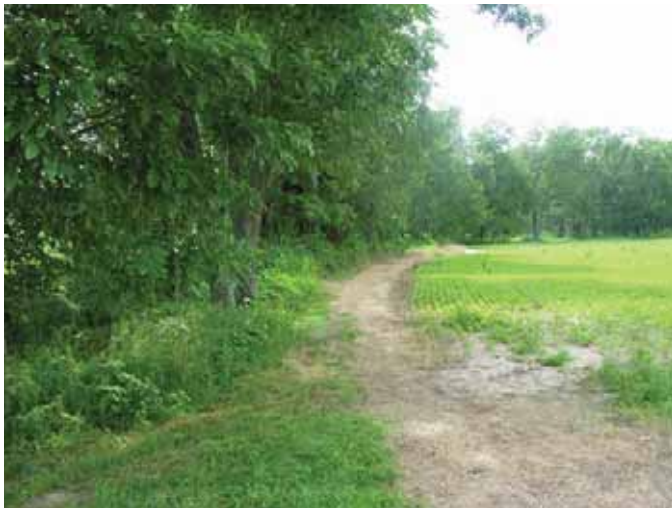
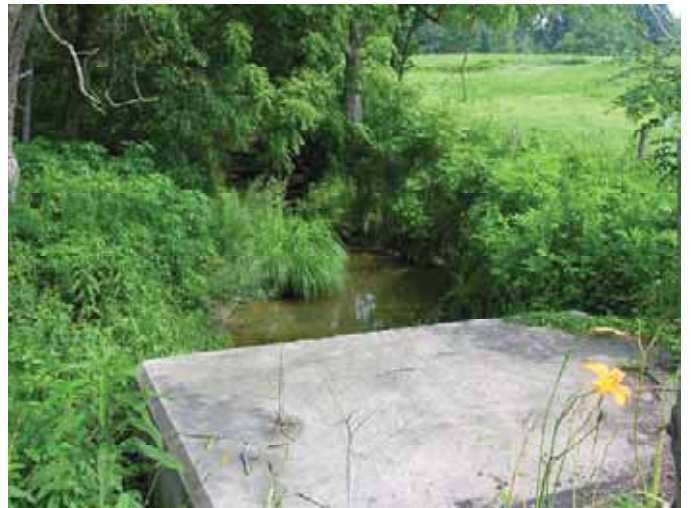
Photographs 17-18. Straight Creek riparian corridor east (left) and west (right) of Martin Alexander Rd.

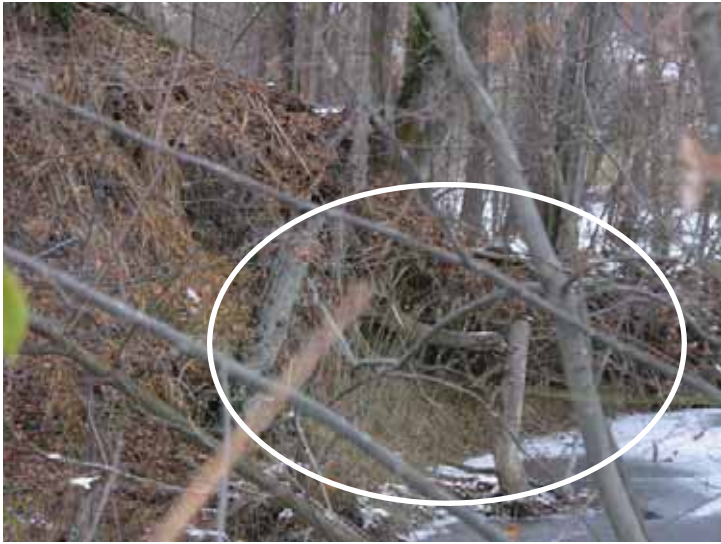
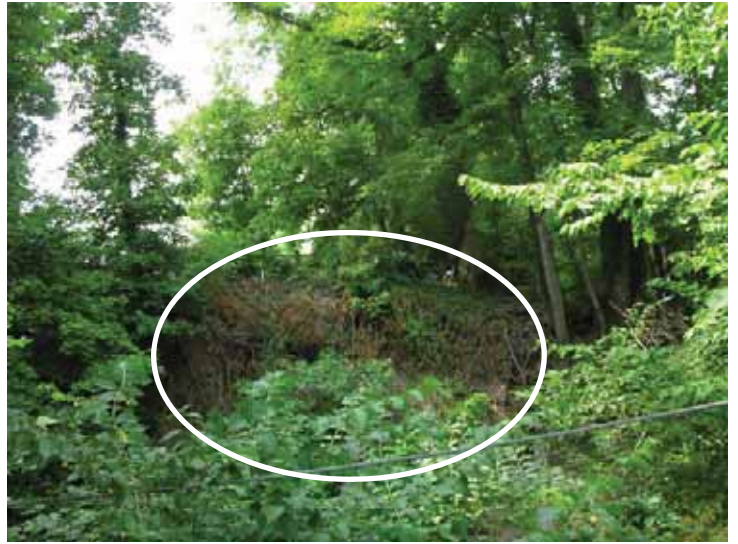
Photographs 19-20. The eroded west bank of Straight Creek is visible through the trees.

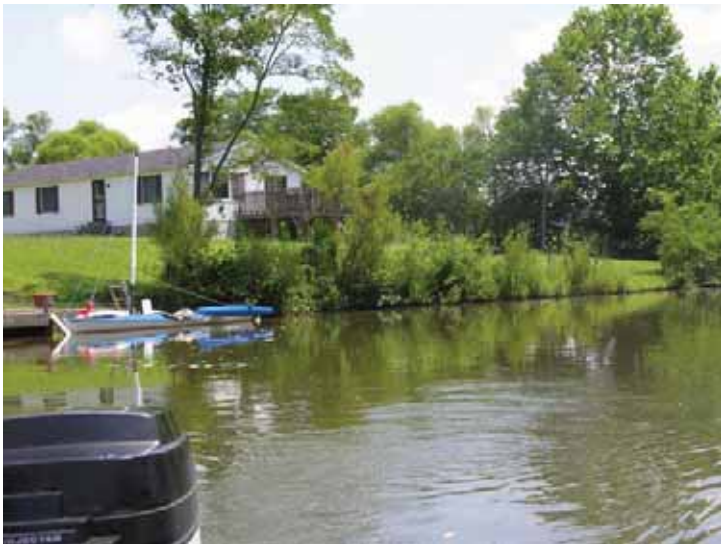
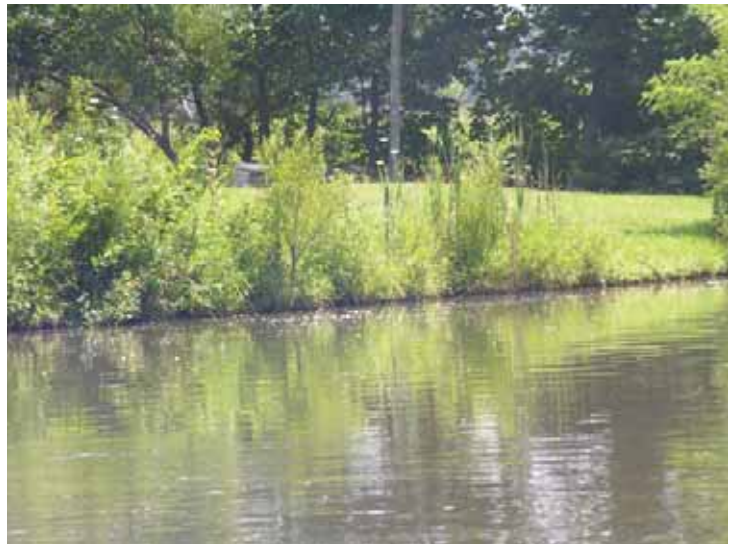
Photographs 21-22. Straight Creek downstream sample locations.

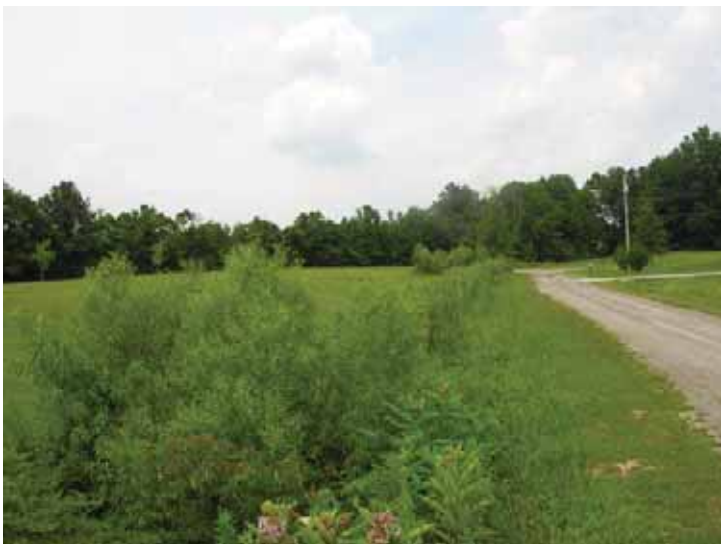
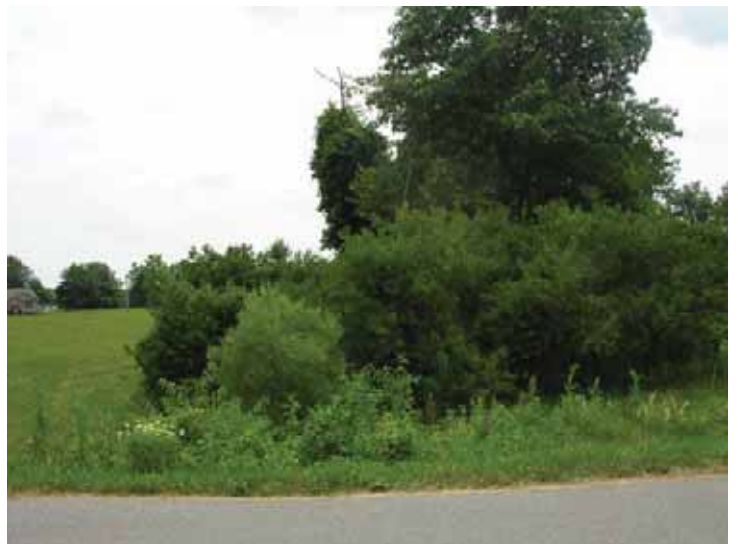
Photographs 23-24. Tributary to Cove 8 looking north (left) away from the lake and south (right), toward the lake.

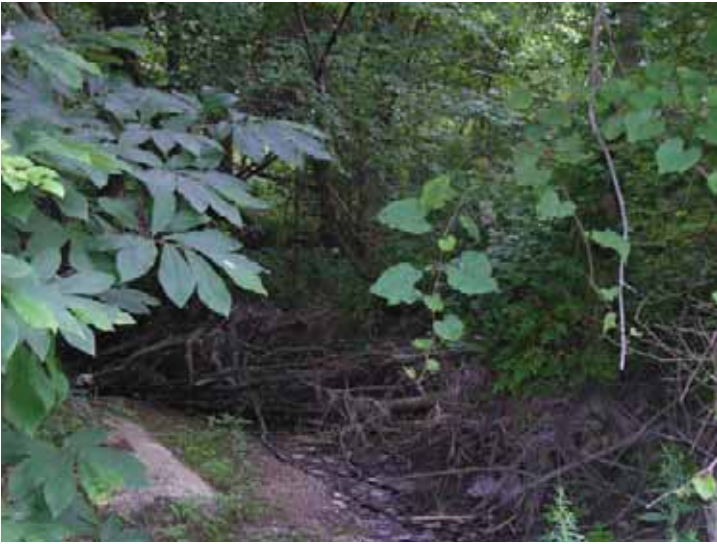
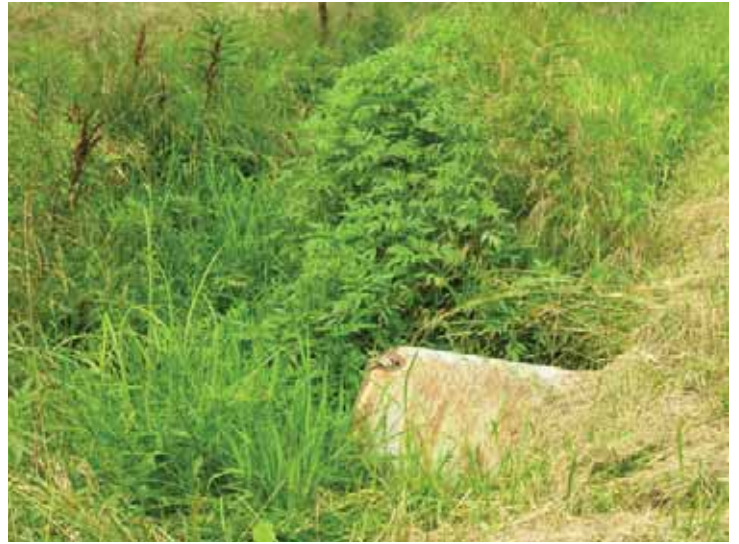
Photographs 25-26. Tributary to Cove 8 off of Louderback Rd. has a dense overstory canopy with a sparser understory.

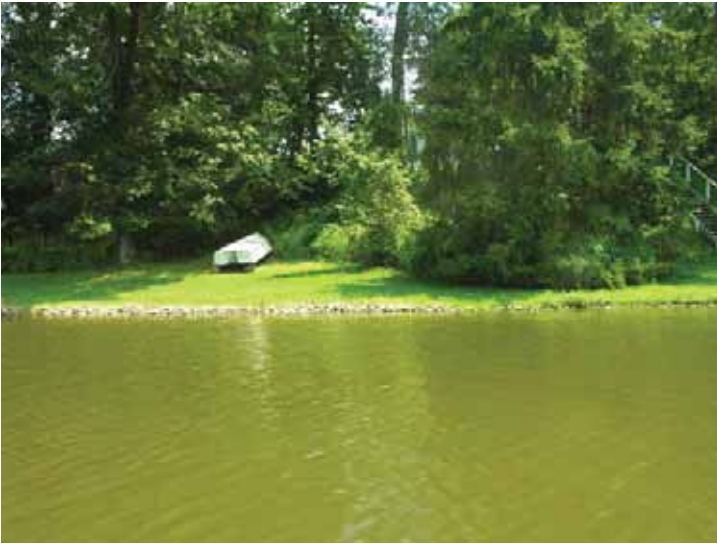
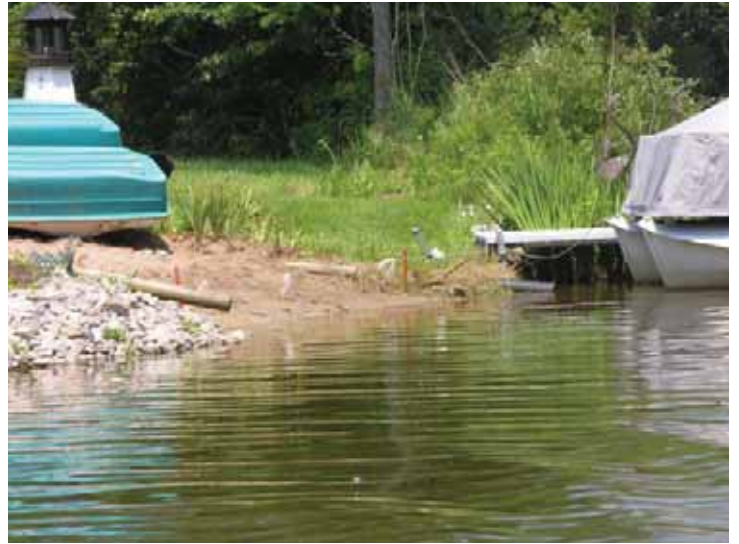
Photographs 27-28. Tributary to Cove 8 downstream sample location.

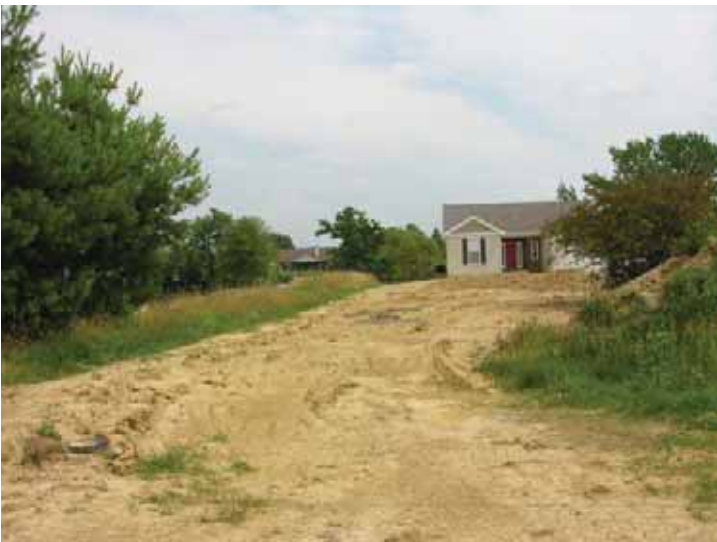
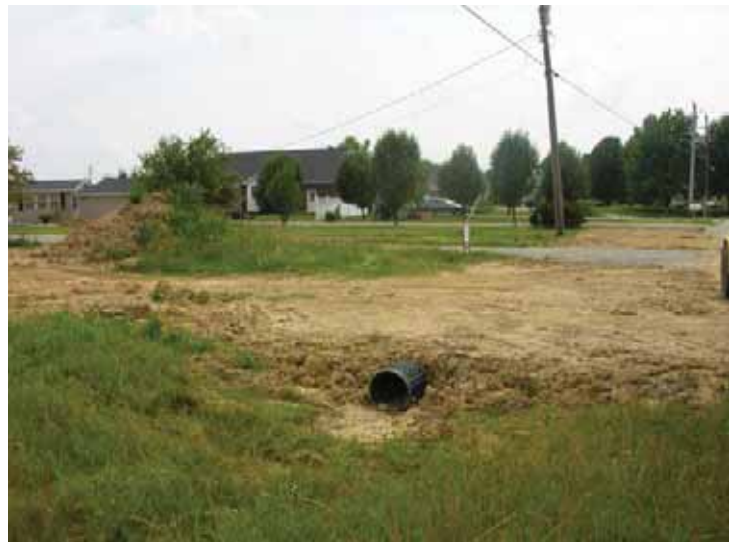
Photographs 29-30. The drainage area to Cove 11 has many developing lots that lack sediment and erosion control.

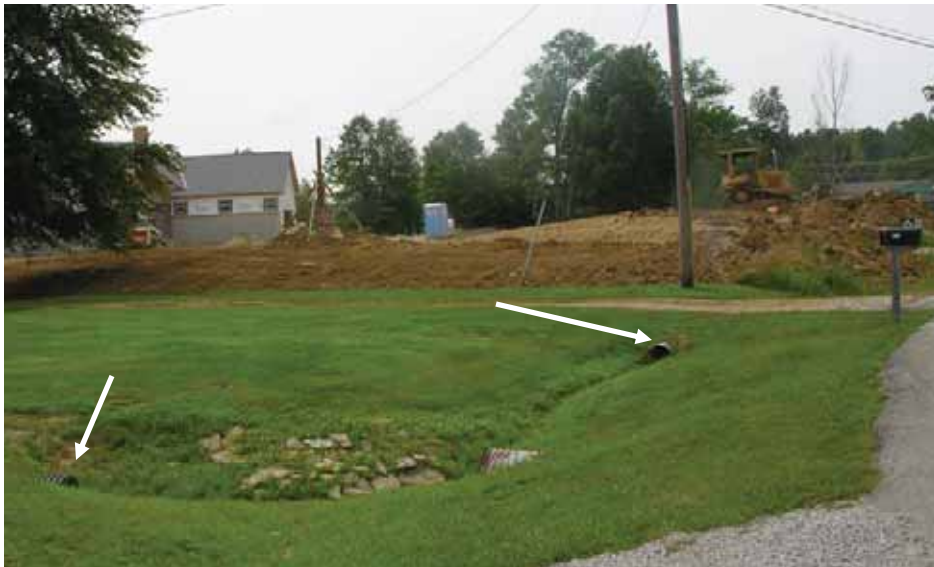
Photographs 31-33. Lot 421 on Cove 11, does not have silt fence in the front or on the sides, where sediment can reach the lake via culverts, indicated by white arrows. Silt fence is present in the rear, but had a gap during our July visit (indicated by circle on lower left photo).

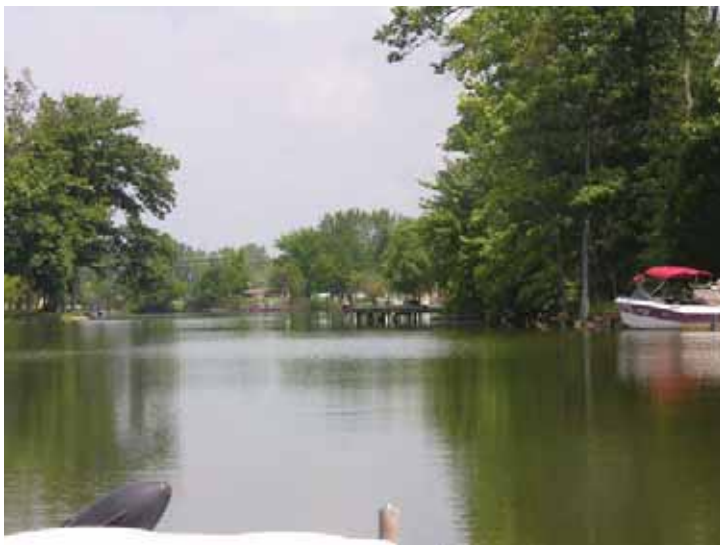
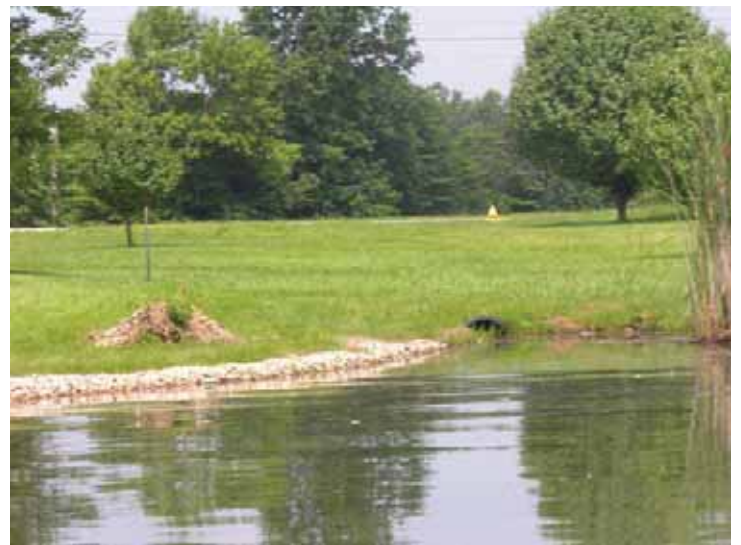
Photographs 34-35. Cove 13 and at the downstream (left) and upstream (right) sample locations.

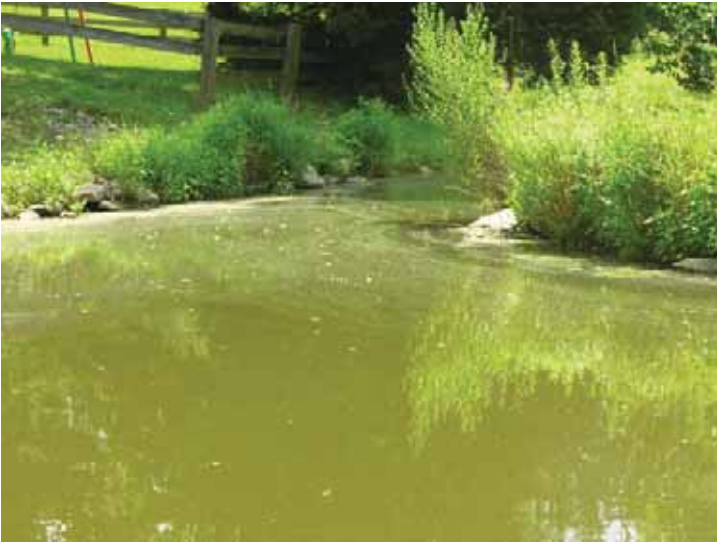
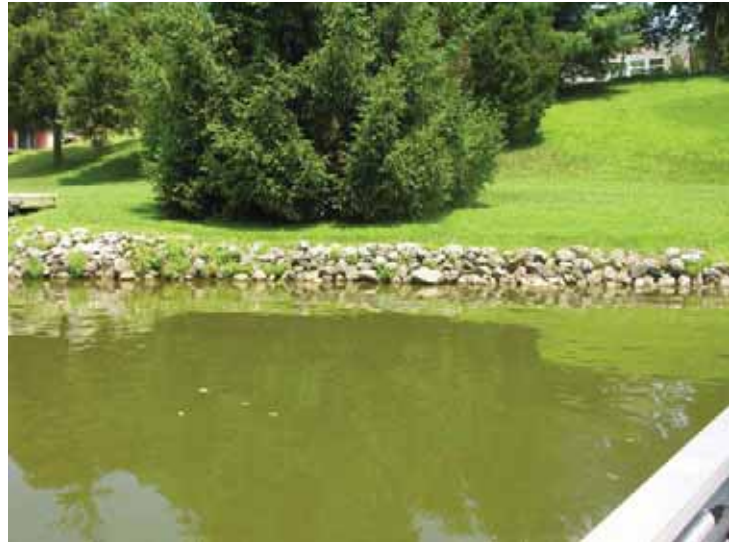
Photographs 36-37. The upstream (left) and downstream (right) sample locations in Cove 4 (Kiddie Corral) had fairly green water indicating that a large concentration of phytoplankton may be present.

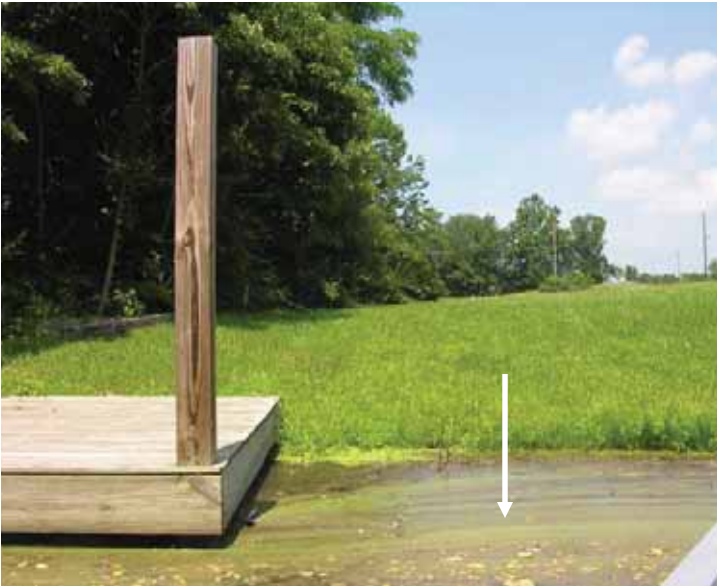
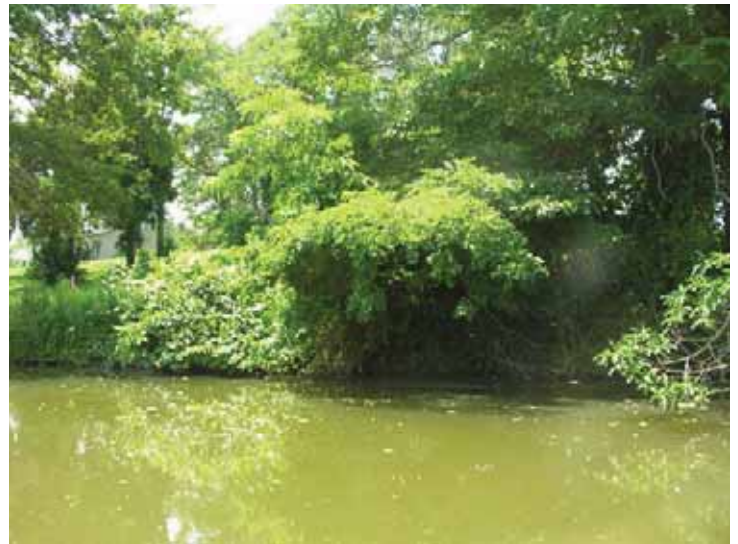
Photographs 38-39. Tributary to Cove 8 upstream sample location. Note the algae on the water surface in the left photo and the green cast to the water in the right photo.

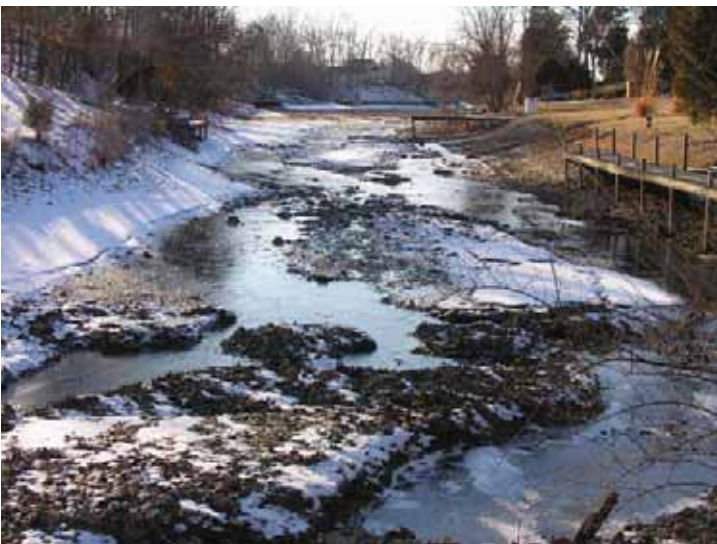
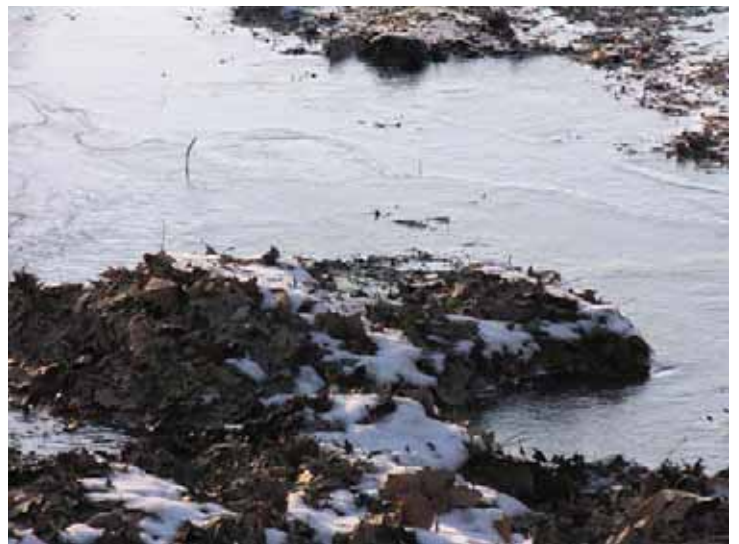
Photographs 40-41. A large amount of organic material is present in Cove 4 (Kiddie Corral), more than observed in any other cove.

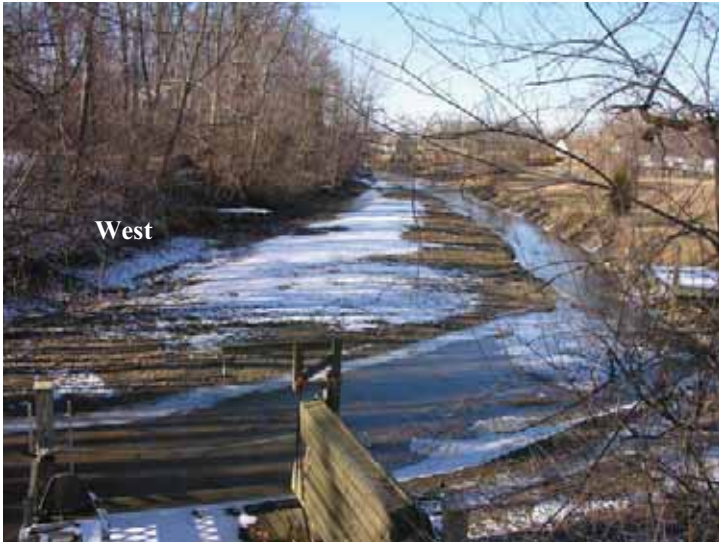
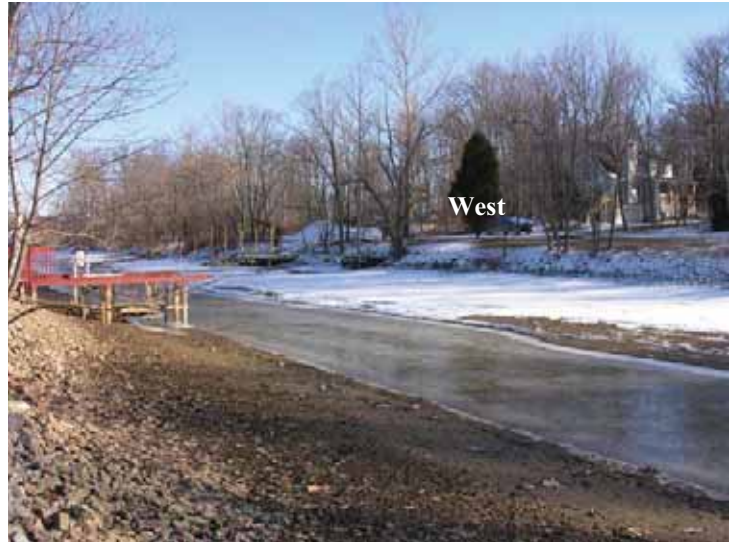
Photographs 42-43. Straight Creek has a large amount of sediment accumulating along the west side of the channel.

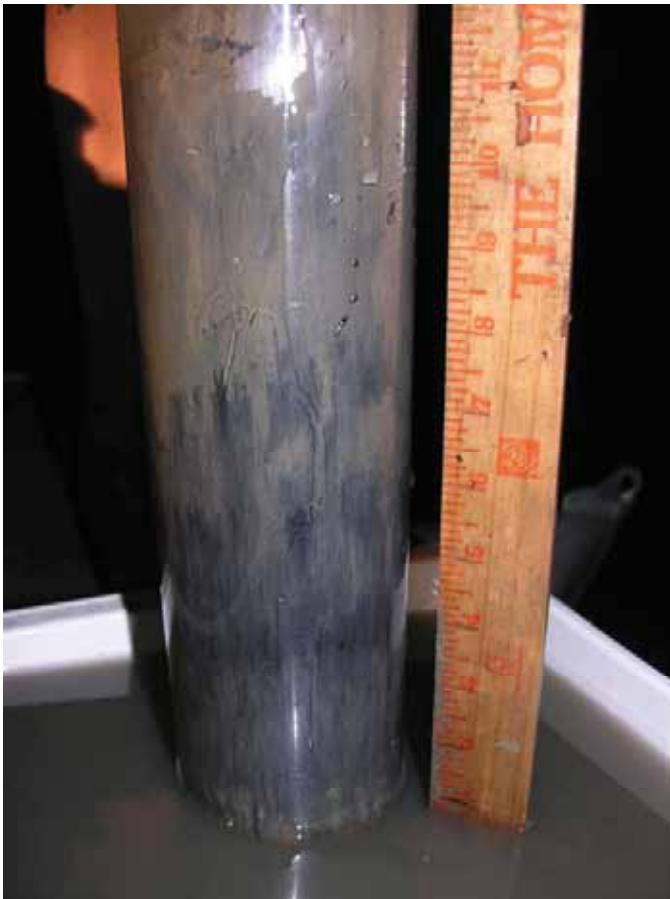
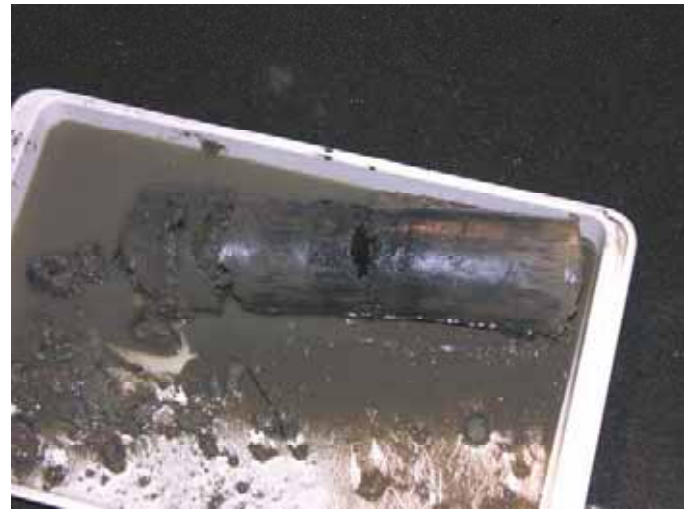
Photographs 44-45. Cove 4. Sample points two and three (left and right) had significantly more silt present than gravel or sand.

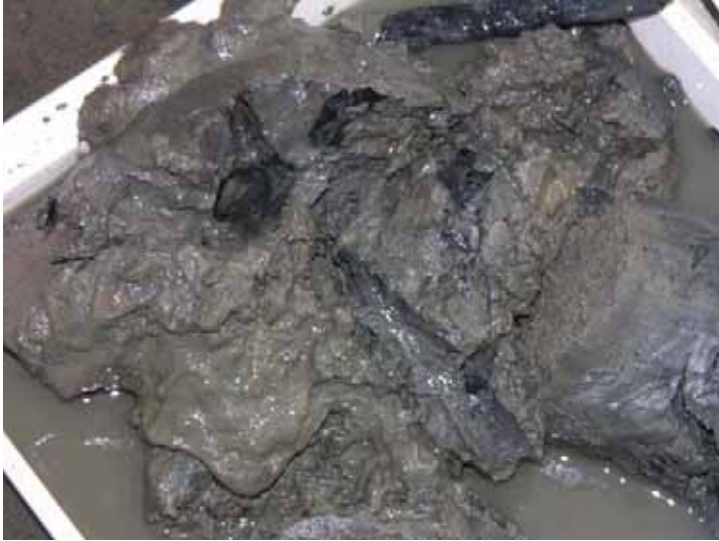
Photographs 46-47. Cove 8. Sample points one and three (left and right) had significantly more of the smallest size grains than gravel.

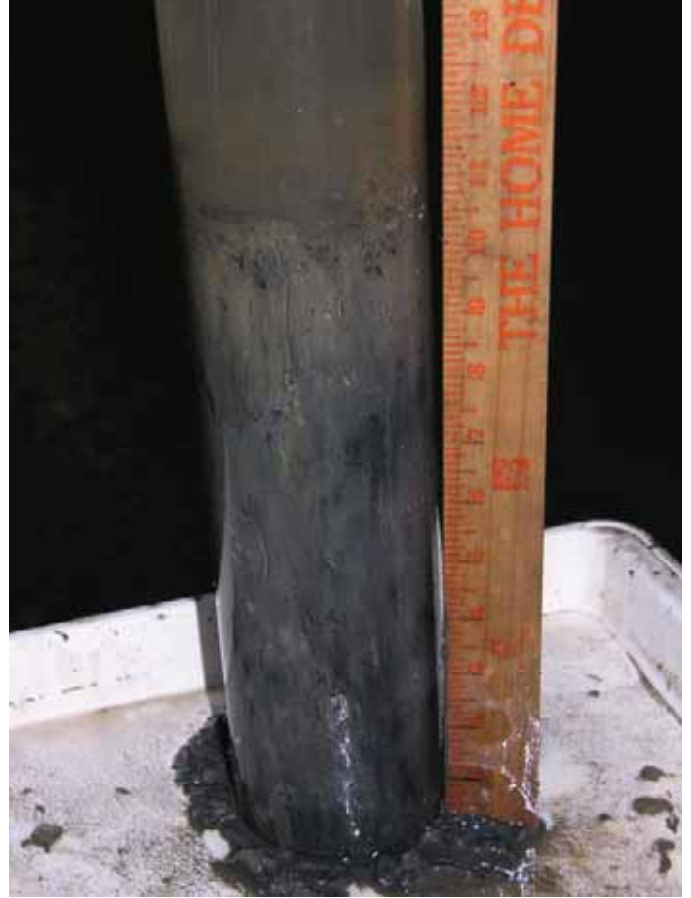
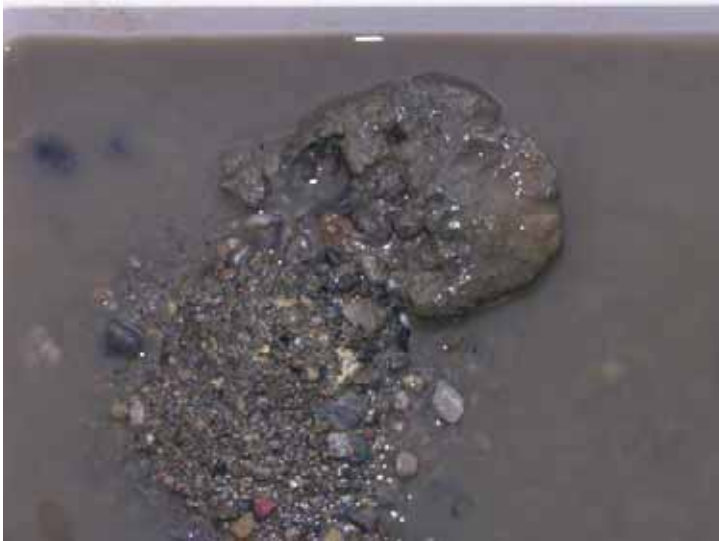
Photograph 48 (left). Straight Creek sediment sample had significantly more sand than very fine sand, silt and clay.
