Lake Waynoka Bathymetric Mapping Summary

May 17, 2011

Subject: Lake Waynoka Bathymetric Mapping Summary

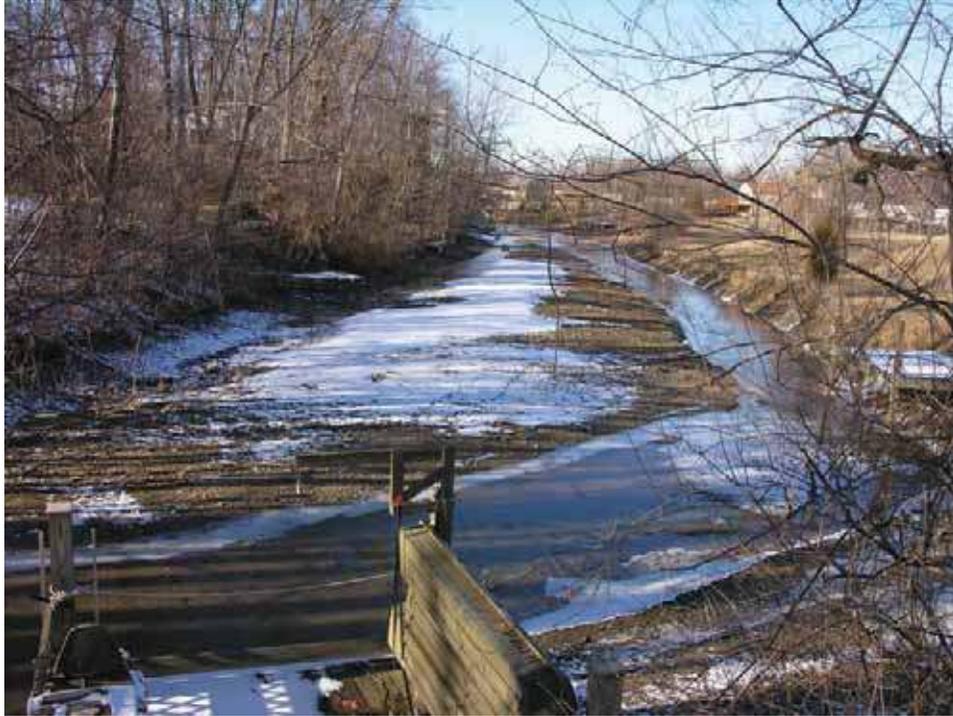
Photograph 1. View from the east end of Straight Creek looking toward the lake. Note the sediment buildup (exposed sand/silt bar) on inside bend (left side) of Straight Creek.

It is important to note that although the water depths measured in some of the coves did not significantly differ from the original water depths, they are very shallow and are likely to become even more shallow if subjected to high sediment loading from upstream. In the cove fed by Straight Creek, we measured minimum water depths of 1.9 feet, which translates to an elevation of 992.58 ft AMSL. This elevation is actually slightly lower than what we were able to interpret from the 1961 topo map, possibly as the result of past dredging. In addition, while recording water depths from the pontoon boat, we stayed primarily within the deepest portion of the channel, meaning that areas outside this main flow path may be shallower than 1.9 feet. The difference in elevations for the erosional outside bend and depositional inside bend of Straight Creek at the eastern-most end of Lake Waynoka is visible in the attached photographs taken in February 2011.

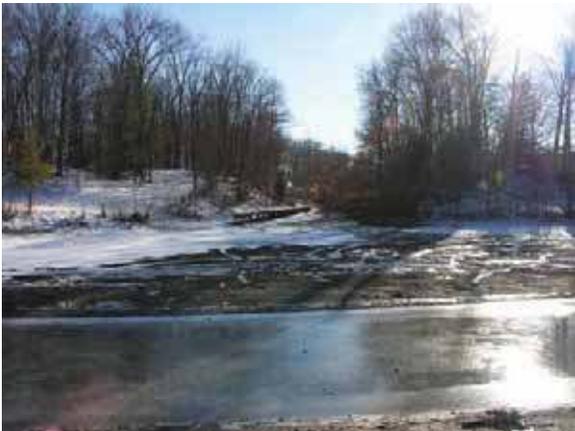
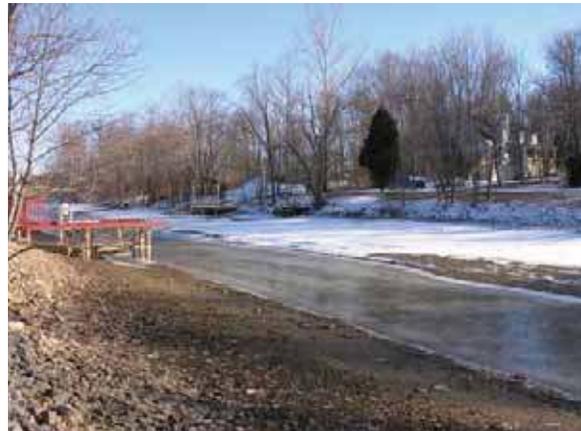
Photographs 2 and 3. Views of the Straight Creek channel looking toward Hiawatha (left) and looking upstream (right).

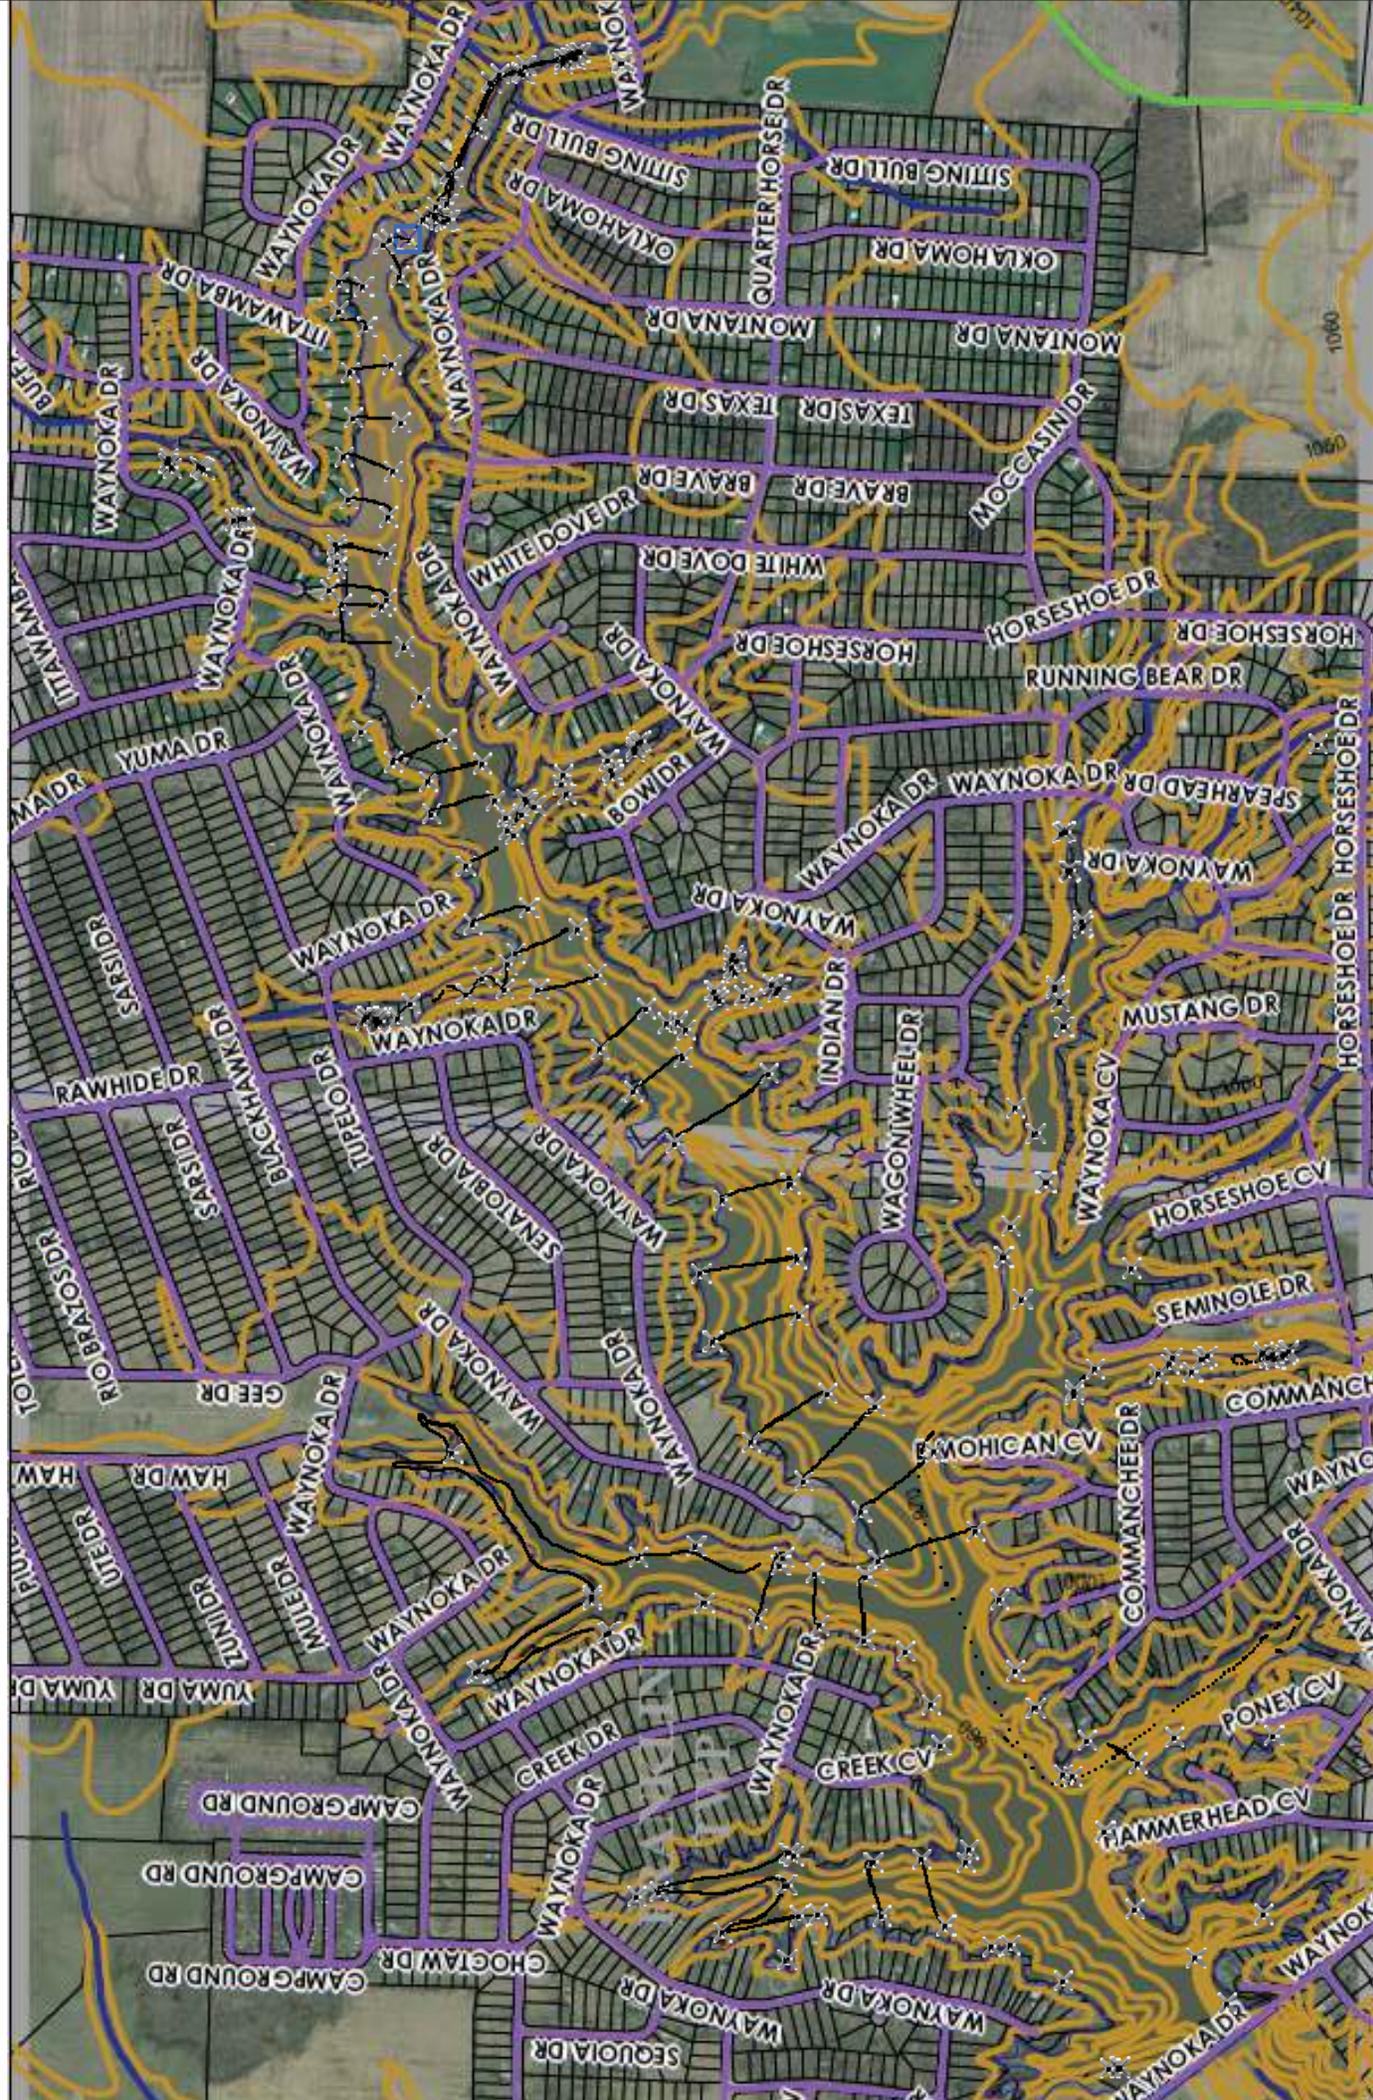
Figure 1. The locations of each transect traveled by the RiverSurveyor is shown on this aerial which is overlain with the 1961 topographic map. The black lines indicate the transect and x's indicate the starting and stopping locations. This aerial with the topographic overlay can be obtained from the Brown County GIS website.

Over a three-day period in April (11-13), we collected water depths from within the lake using a combination of a highly accurate Acoustic Doppler Profiler (ADP) system known as the RiverSurveyor and a hand-held depth sonde. The RiverSurveyor was attached to the side of a pontoon boat and used to measure water depths in the main body of the lake and the larger coves. Transects were sampled from bank to bank and were spaced roughly 250 feet apart. A total of 40 transects were measured across the main body of the lake and another 35 in the large coves. The depth sonde was used to measure water depths in areas that were too narrow for the pontoon boat to easily maneuver. Multiple measurements were collected with the depth sonde in each cove. Figure 1 depicts the transect and supplemental depth measurement locations superimposed on a topographic map available on the Brown County GIS website.

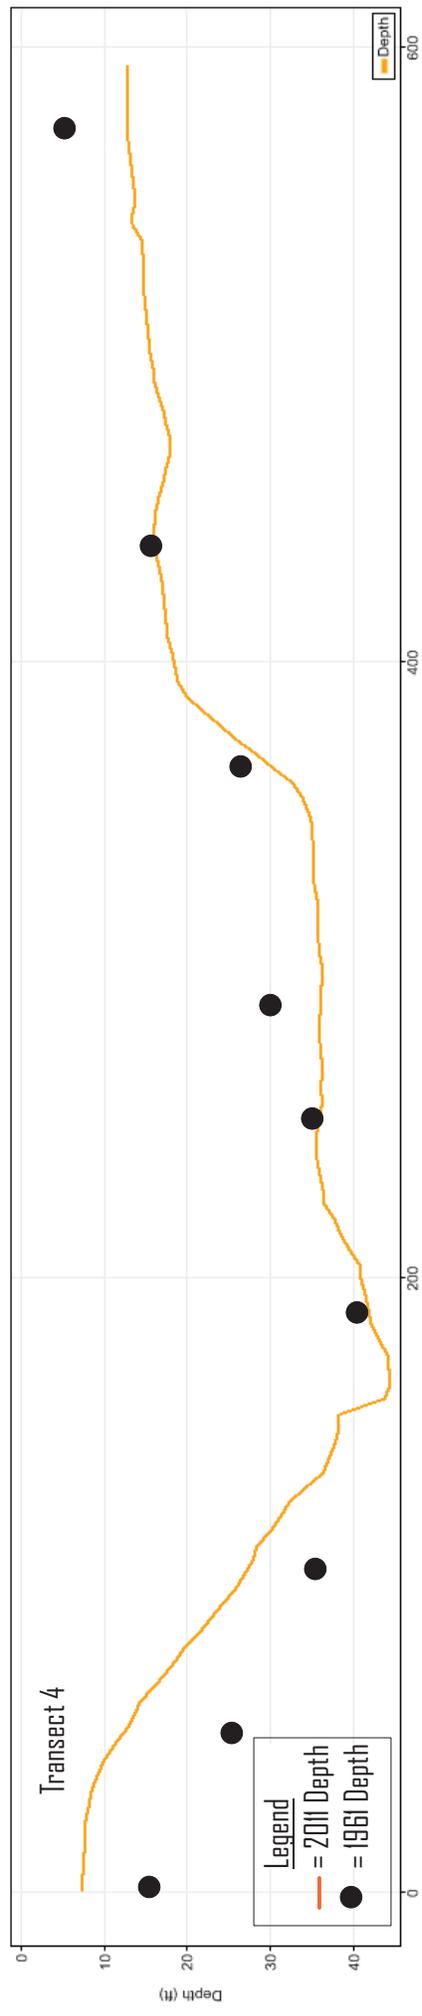
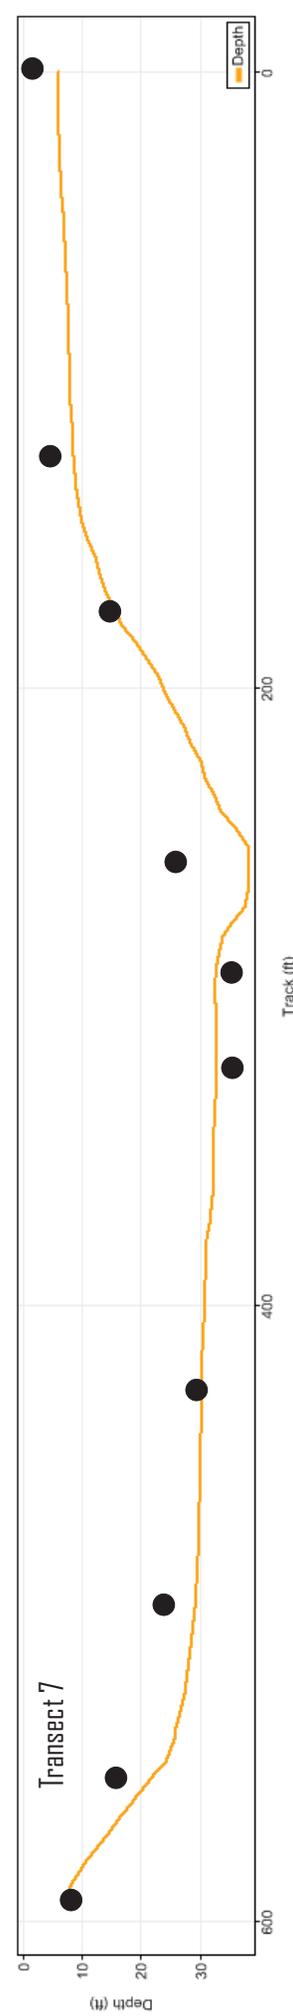
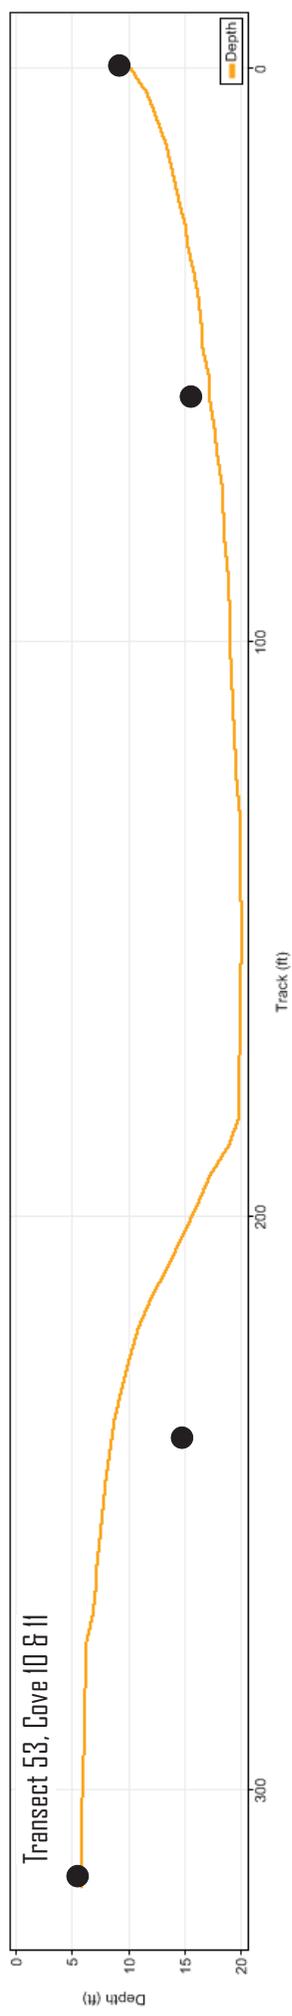
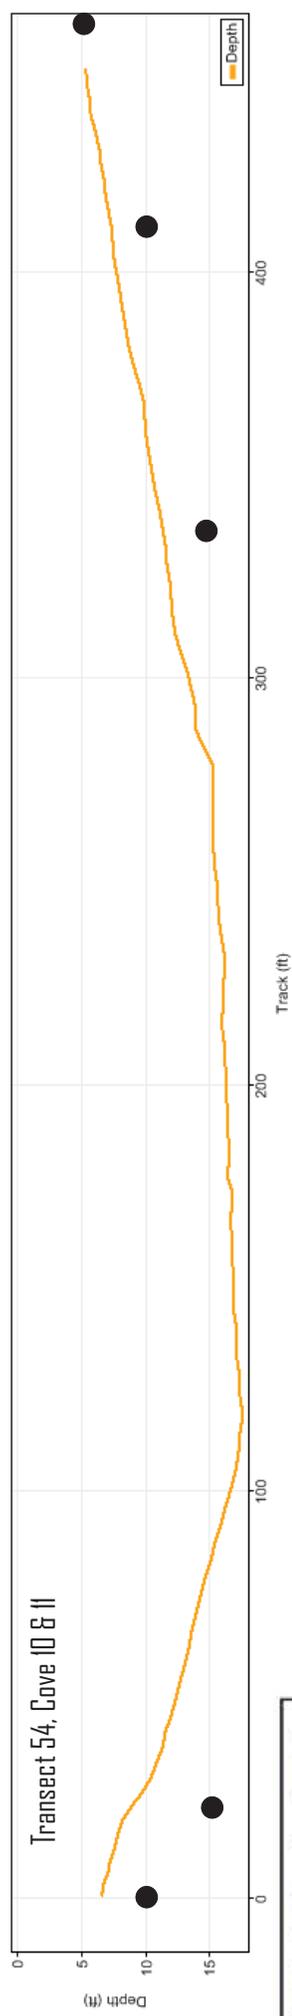
Figure 2. Selected topographic profiles from the bathymetric survey of Lake Waynoka. The x-axis shows the distance traveled between banks and the y-axis shows the water depth. Depths measured in 2011 were recorded continuously and are shown as a line, while the 1961 depths were interpolated from the 1961 USGS Topographic map and are not continuous.

Figure 2 illustrates topographic profiles from four of the transects that we measured, and Figure 3 shows the location of these transects on the lake. These comparisons show that the depth profiles for the transects generally agree with the original topographic maps, in that the average and maximum depths indicated for these two data sources are very similar. Because no depths differed from the original topographic map by more than 10 feet, and we do not have the appropriate resolution (*i.e.*, 1-foot intervals) maps to complete a more refined assessment of the existing depths, the 1961 map is deemed to remain the most accurate map available for interpretation of depths across the lake.

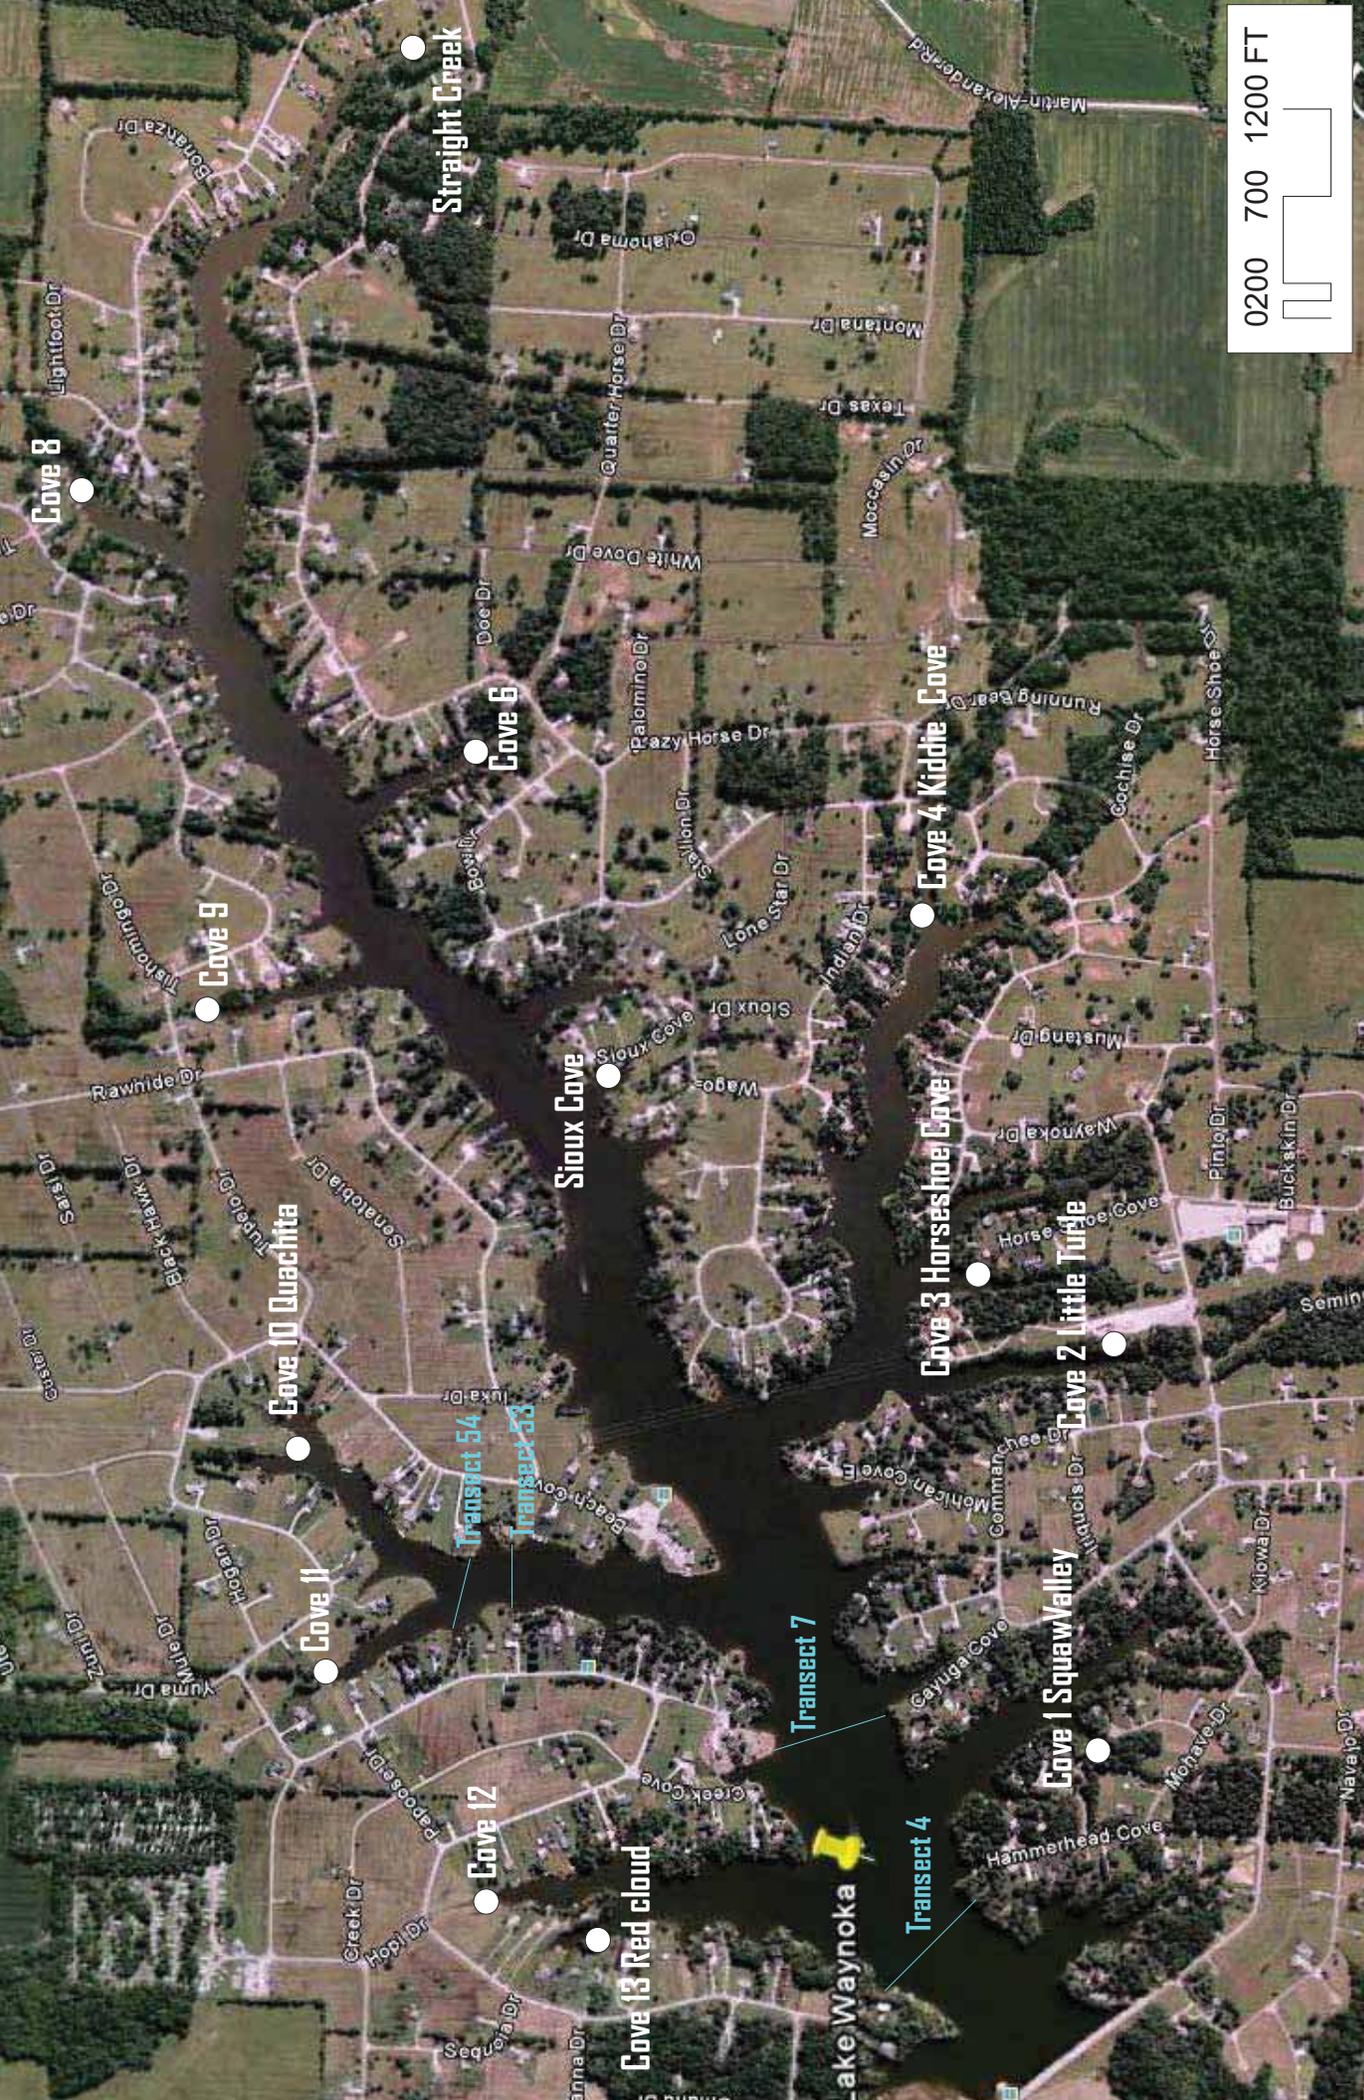
Figure 3. Locations of Representative Transects (Depth Profile Comparisons) and Total Suspended Sediment Samples

2011. These samples were analyzed for TSS concentrations, to provide an indication of where sediment accumulation may present the greatest potential problems for Lake Waynoka property owners. Of the 13 samples, four had very high concentrations of TSS (Kiddie Koral, Cove 6, Straight Creek, and Cove 8), thus these areas are of particular concern. Figure 3 includes points to indicate the locations from which these TSS samples were collected. The TSS concentrations are shown in terms of milligrams of sediment per liter lake water (mg/L) on the lab output from Advanced Analytics. Note that reporting limit refers to the lowest concentration of TSS that the method is able to measure.
