Subject: Condition assessment of Lake Waynoka in Brown County, Ohio

At the request of the Waynoka Property Owners Association (WPOA), MAD Scientist Associates, LLC (MAD) visited Lake Waynoka in Brown County, Ohio, to conduct an evaluation of nuisance vegetation growing in the lake.

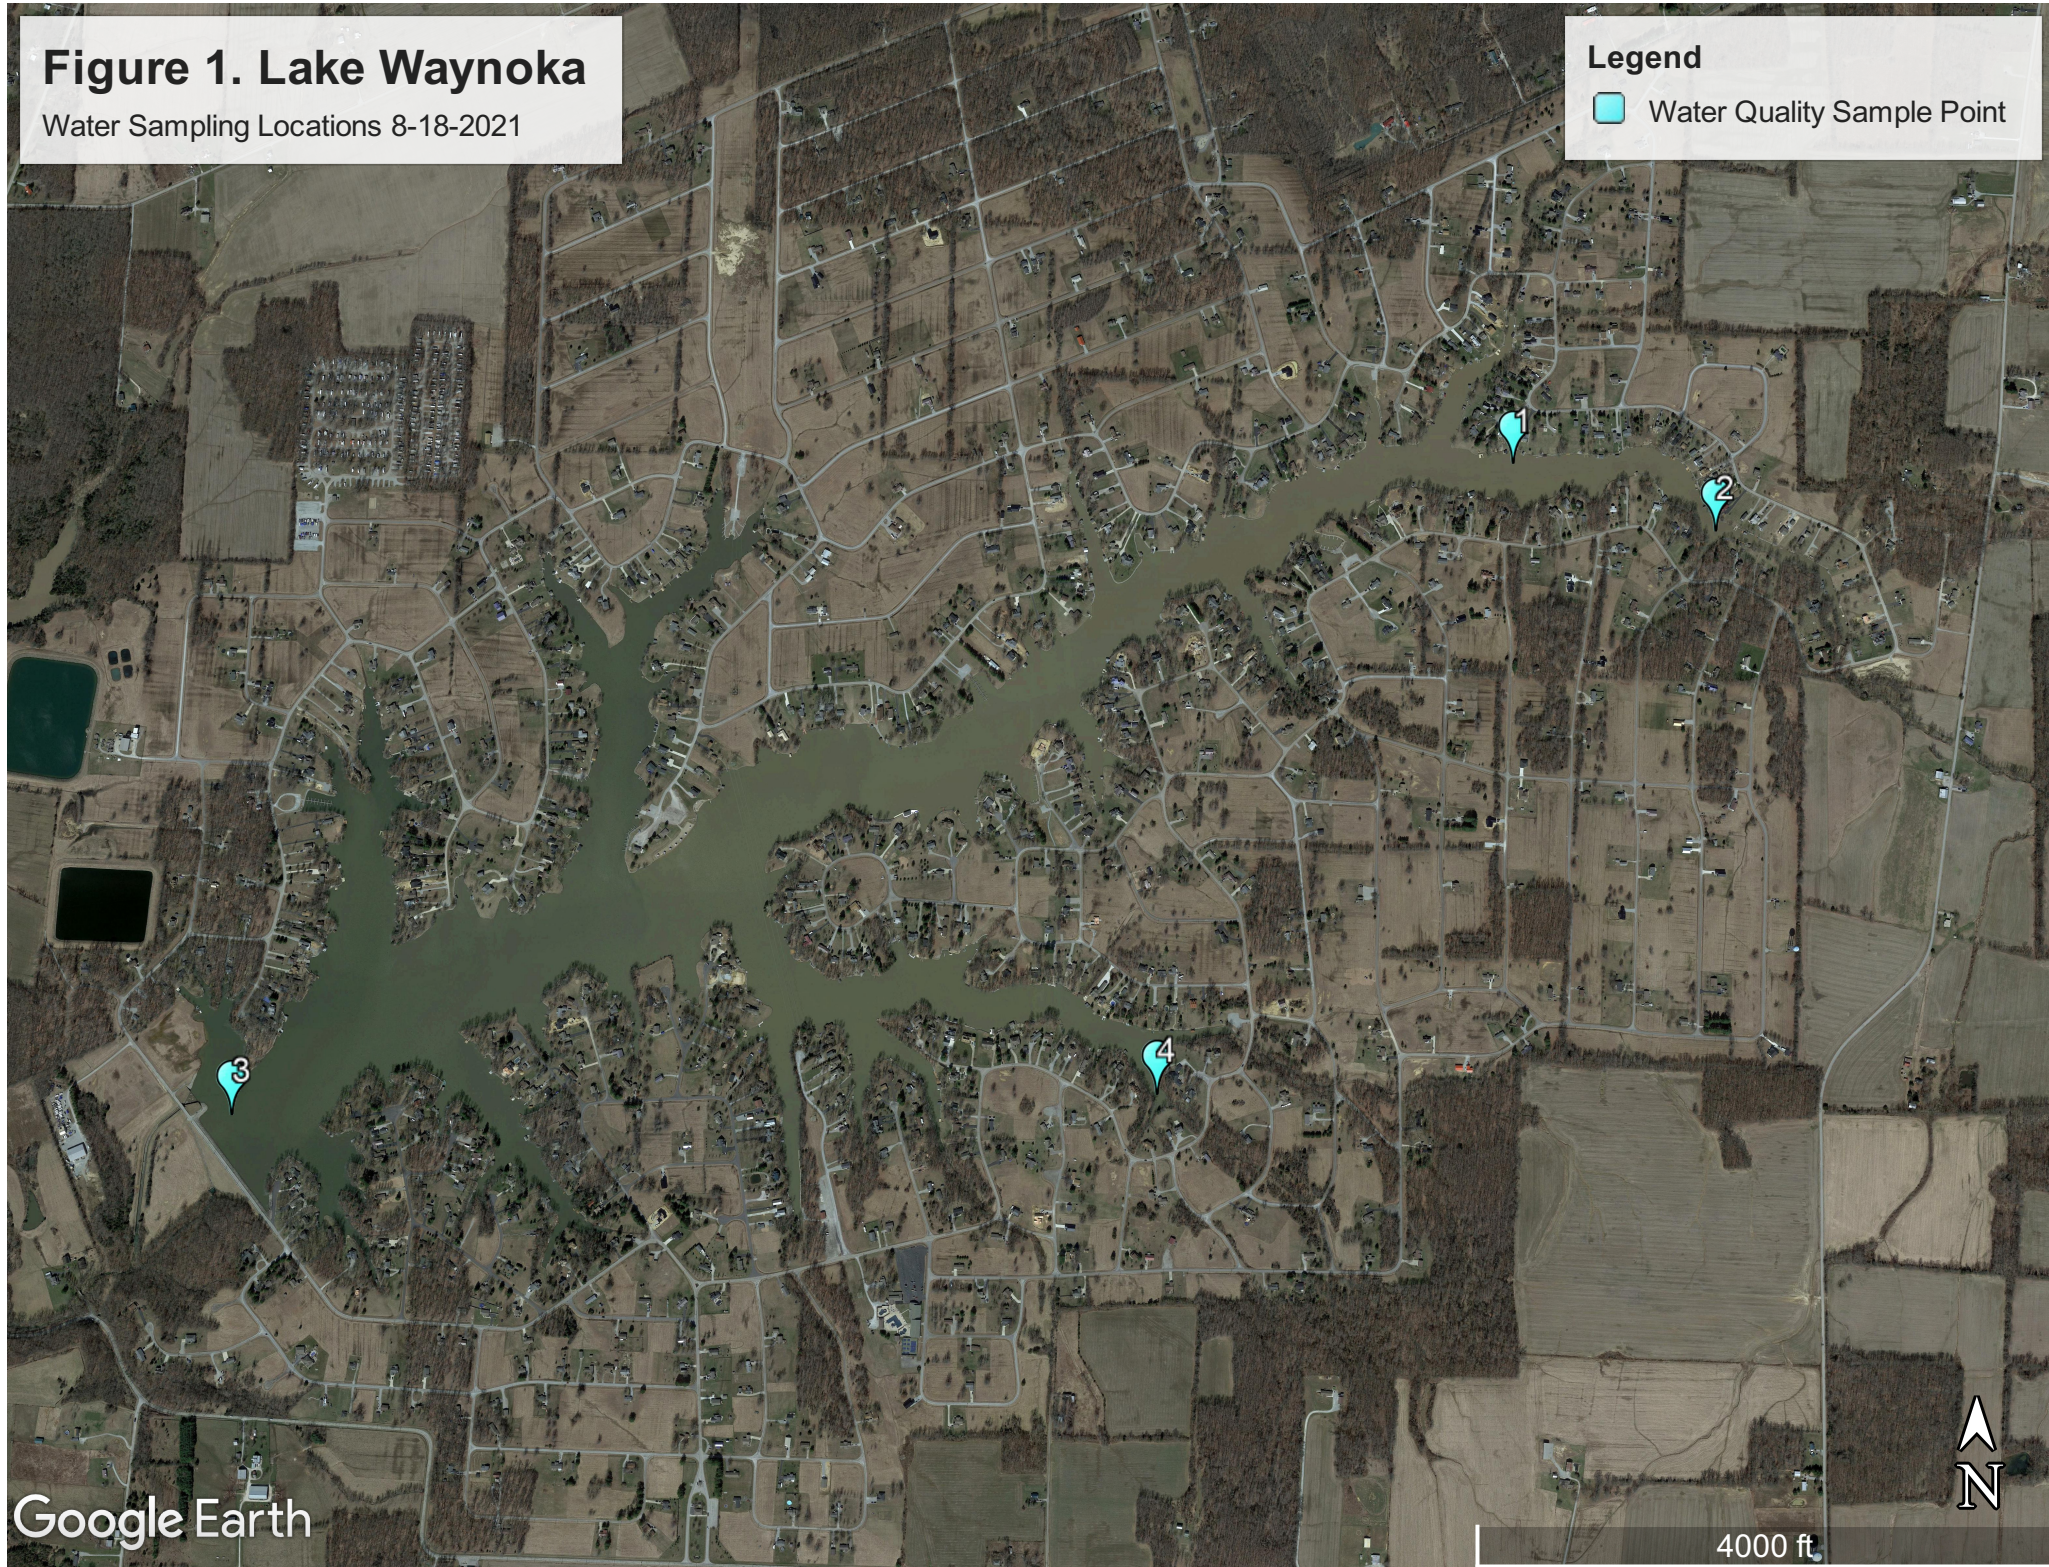
# Figure 1. Lake Waynoka

Water quality does not appear to be a primary factor driving where vegetation was growing. There were few differences observed among the four water quality sampling locations (Figure 1, Appendix B). There was also no apparent trend between water quality parameters among areas that had abundant SAV and areas with none. This is an area for continued research if more sampling is feasible in the future. Other factors, such as the proximity of propagule sources (seeds, plant fragments, etc.), sediment quality, sunlight exposure, water currents/wave action, and the efficacy of chemical treatments may be responsible for the uneven distribution.

Water Sampling Locations 8-18-2021

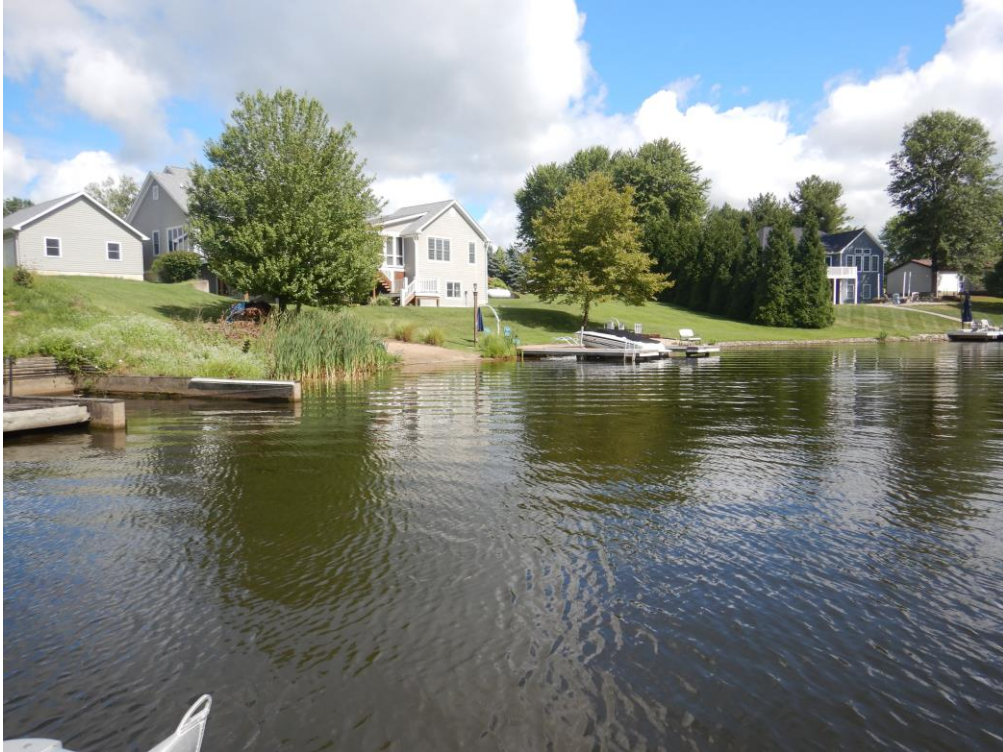
Leafy pondweed (*Potamogeton natans*), Cattail (*Typha* sp.), American lotus (*Nelumbo lutea*) and filamentous algae (*Spirogyra* sp.) were observed in various areas, but in low amounts (Appendix A, Photograph 1). Brittle naiad (*Najas minor*) was the primary submersed aquatic plant observed, and it was locally

Photograph 1. General view of Lake Waynoka on the day of sampling. Few homes have natural habitat such as cattails (*Typha sp.*). Photograph taken in central region of Lake.

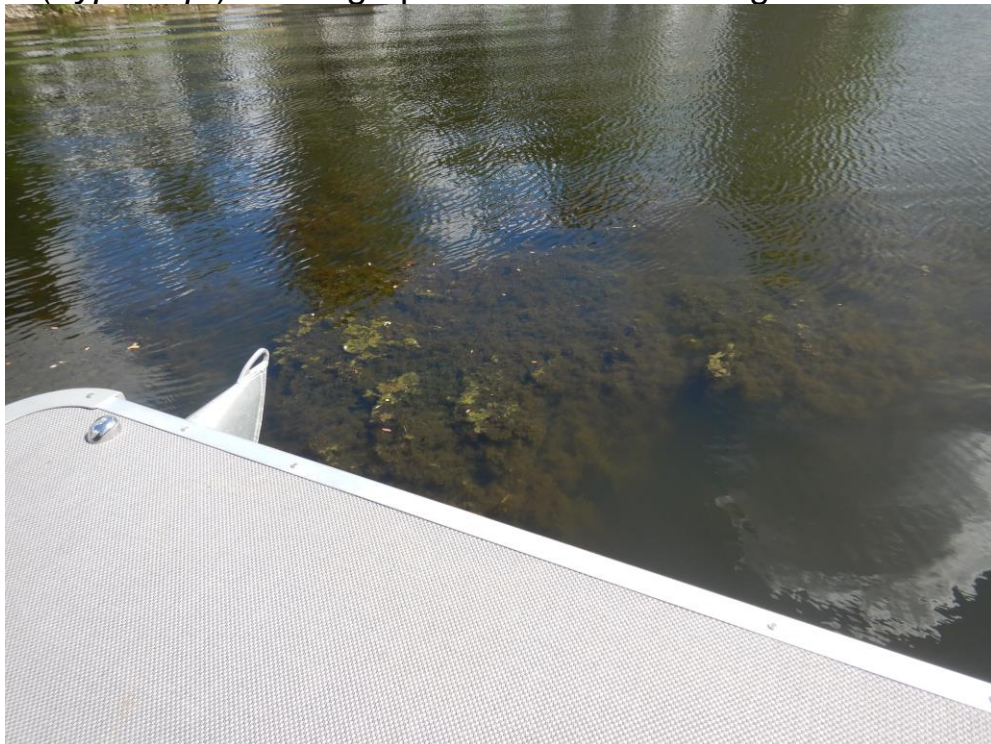
very abundant and often found in large masses where present. This SAV has reached sufficient densities that it is considered a nuisance (Appendix A, Photographs 2-3).

Photograph 2. Brittle naiad (*Najas minor*) spread in various amounts throughout the lake.

Brittle naiad is an annual and fragile plant, as the name suggests. It starts growing early in the season and spreads through seeds and plant fragments. Even a small piece that breaks off can be transferred and spread elsewhere; thus, mechanical treatment is not recommended. Herbicide treatment can be conducted using a wide range of aquatic use herbicides, including but not limited to endothall, fluridone, diquat dibromide and flumioxazin. These treatments may also have damaging effects to other aquatic life. Copper Sulfate is another method of control, but as observed with previous treatments of Copper Sulfate in Lake Waynoka, the SAV rebounds after only a few weeks post-treatment.

Biological control of aquatic plants (including SAV) using triploid (sterile) grass carp (*Ctenopharyngodon idella*) is an effective treatment that has benefited Lake Waynoka historically. While the grass carp provided effective control of the SAV in recent years, their limited lifespan and the populations' die off may have been a primary factor in the increased growth of SAV seen in the past year.

The Ohio Department of Natural Resources recommends stocking 5 fish per acre when aquatic vegetation covers approximately 25% of the lake. We recommend stocking at a low rate (3 sterile grass carp per acre) for a total of 900 grass carp in the approximate 300-acre lake. This will curtail the spread of SAV and enhance swimming areas, while still allowing some SAV to remain for healthy aquatic biota.

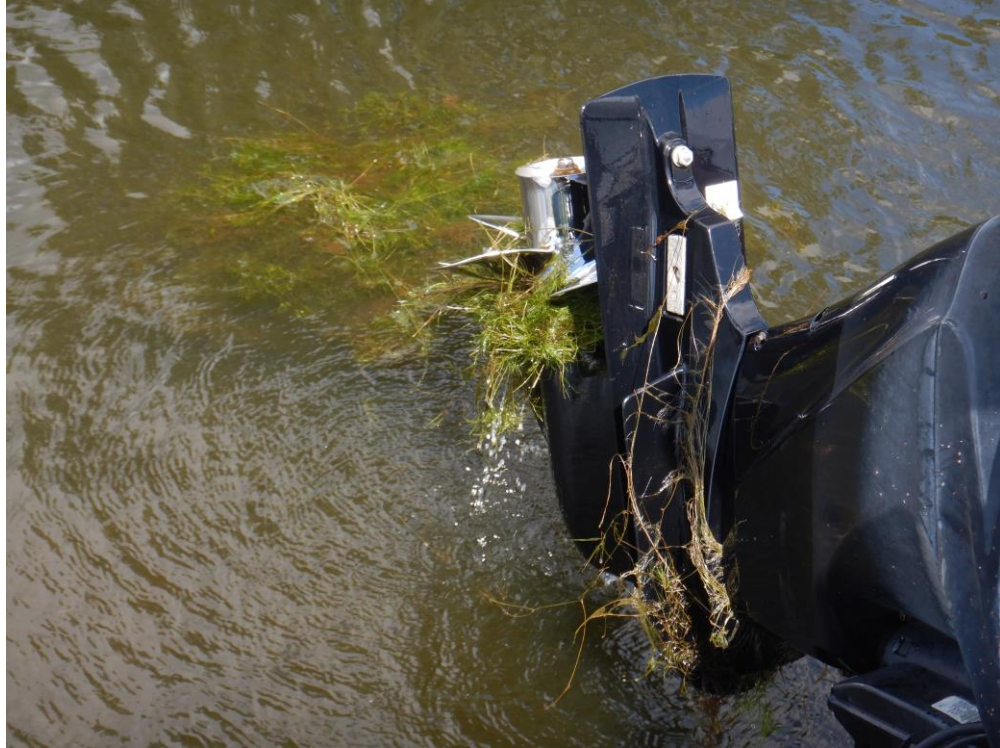
Photograph 3. Submerged aquatic vegetation (SAV) causing a nuisance by getting stuck on boat propeller.

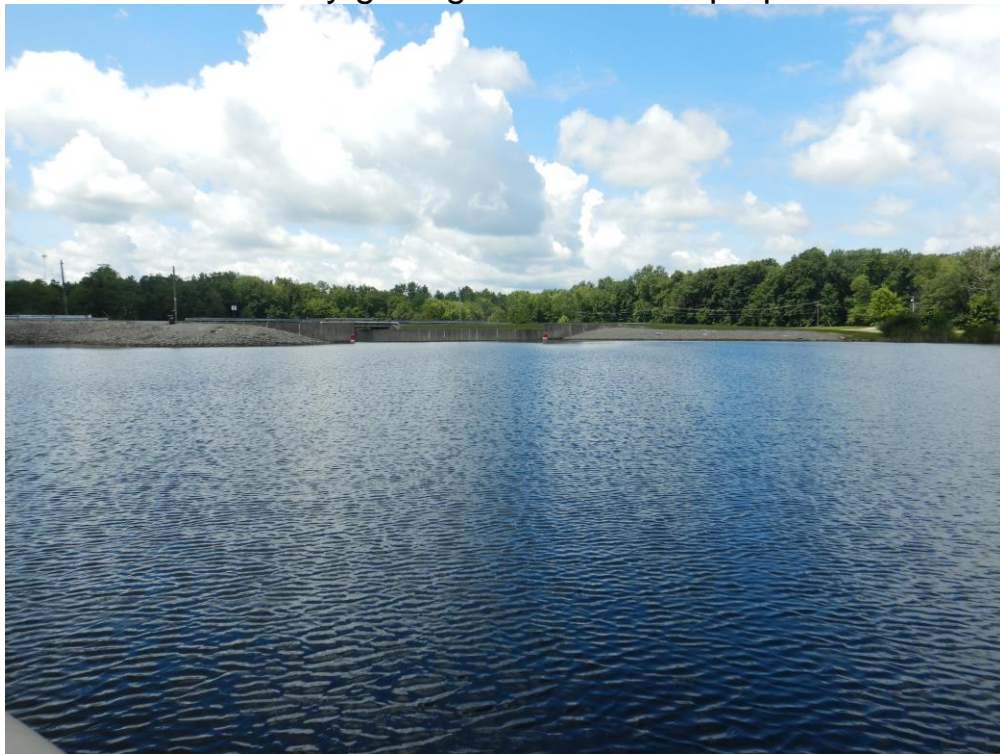
Measured lake depths ranged from 0 to approximately 35 feet. SAV tends to occur in less than 10 feet of water. However, dense SAV was not consistently observed in areas of the lake within this depth range. In some sections of the lake, shallow areas contained abundant SAV while in other shallow areas around the lake SAV was absent. The deepest areas in the lake had no SAV (Appendix A, Photograph 4).

Photograph 4. Deepest area of Lake Waynoka sampled (western portion; #3) which was 35 feet deep and had no SAV present.

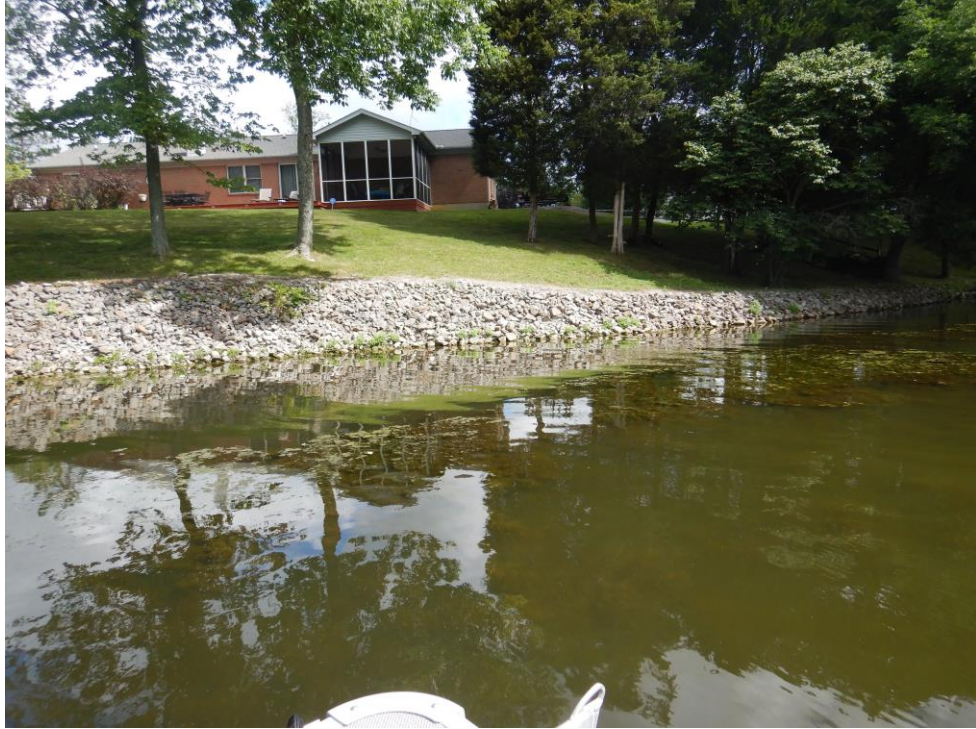
Photograph 5. Many homes had no natural buffer between mowed lawn and lake.

The WPOA Lake Advisory Committee may wish to consider implementing a rule to limit the use of fertilizers near the lake, especially in areas where it would runoff directly into the lake without first passing through a dense, natural vegetated buffer. For properties where there is no such buffer (Appendix A, Photographs 5-6), WPOA could encourage residents to establish one by leaving an unmowed area, possibly planted with native herbaceous vegetation, at the edge of their property to absorb nutrients before they reach the lake (Appendix A, Photograph 7). This recommendation is important to reducing nitrogen and phosphorus loading into the lake. These nutrients promote SAV and algal growth, so reducing the loading will have a positive effect – especially if the use of natural buffers is widely adopted. Establishing additional natural buffers within the lake's watershed will further reduce runoff inputs from non-point sources such as agriculture and general property owner fertilization, providing a more sustainable, long-term solution to benefit the lake system.

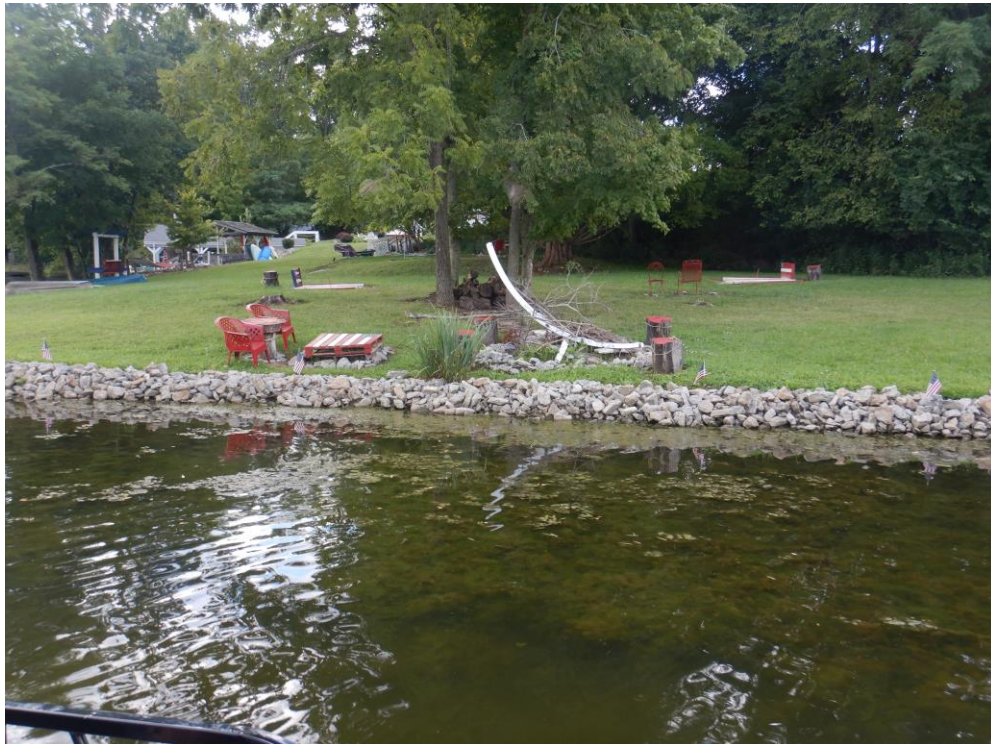
Photograph 6. Additional properties had no natural buffer between mowed lawn and lake.

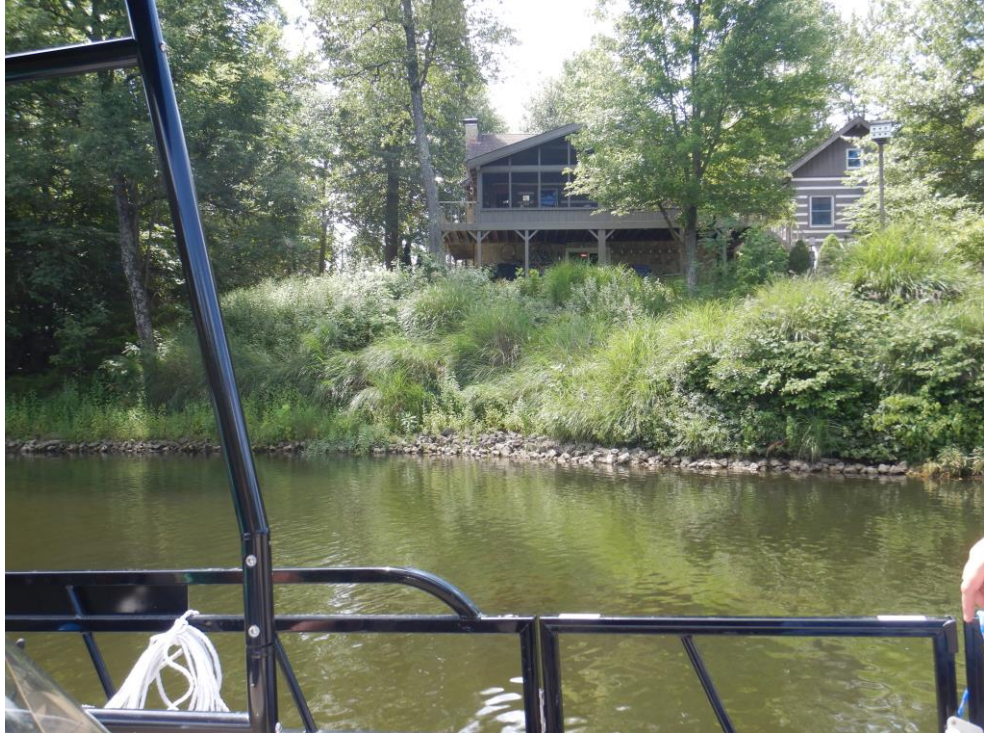
Photograph 7. Example of property with lush natural buffer that prevents high nutrient run-off from entering the lake.

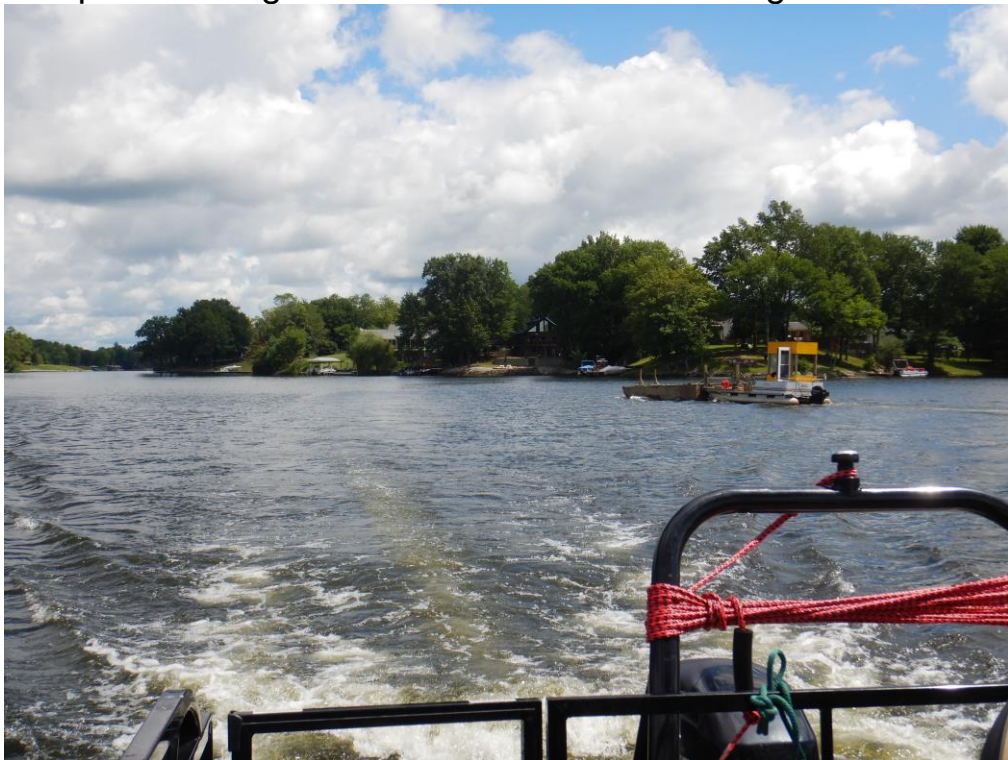
Based on dredging having taken place in the last five years and occurring on the day of the site visit (Appendix A, Photograph 8), disturbance and transfer of materials from the substrate back into the water column may increase nutrient availability and growth of aquatic vegetation. Because of the recreationally-active community around the lake, dredging is expected to be an ongoing activity. Maintaining a calendar and schedule to notify the responsible parties of dredging activities is recommended. MAD recommends that the WPOA schedules dredging outside of the growing season and only as necessary during the summer months (and only in areas where SAV is not prevalent) to reduce the spread of SAV.

Photograph 8. Observation of a dredging boat carrying loads of sediment (and feasibly SAV) across the lake. Photograph taken from the back of the patrol boat.
